**ADDENDUM NO. 1**

**CONTRACT NO. 25-532**

**BUILDING 1 REHABILITATION  
WESTCHESTER COUNTY AIRPORT  
TOWNS OF HARRISON AND NORTH CASTLE AND  
VILLAGE OF RYE BROOK, NEW YORK**

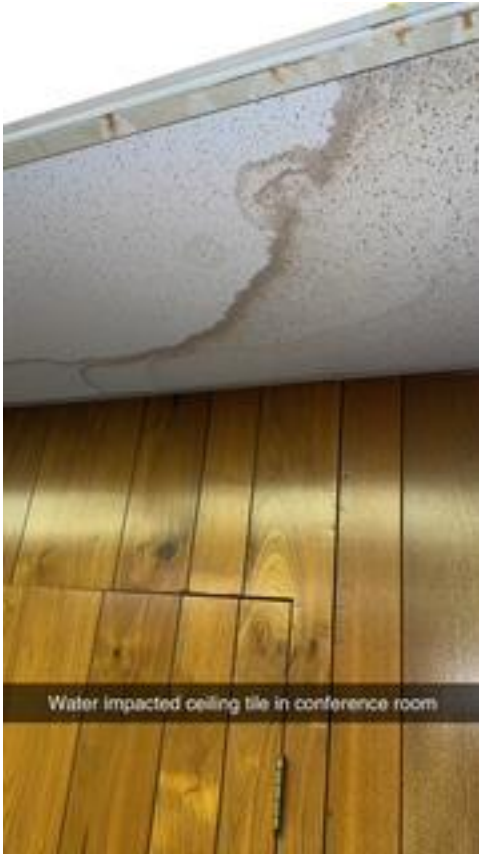
Water impacted ceiling tile in conference room

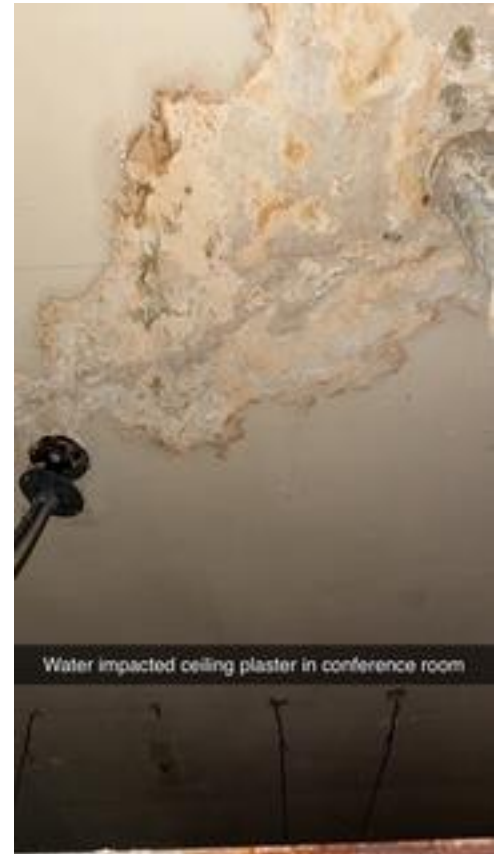
Water impacted ceiling plaster in conference room

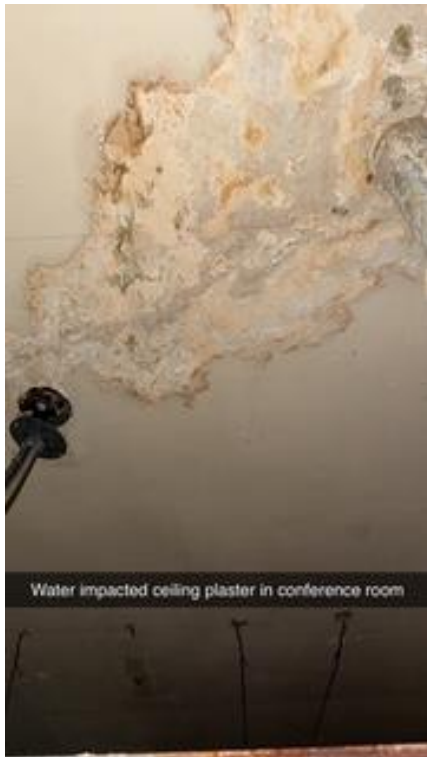
Water impacted ceiling plaster in conference room

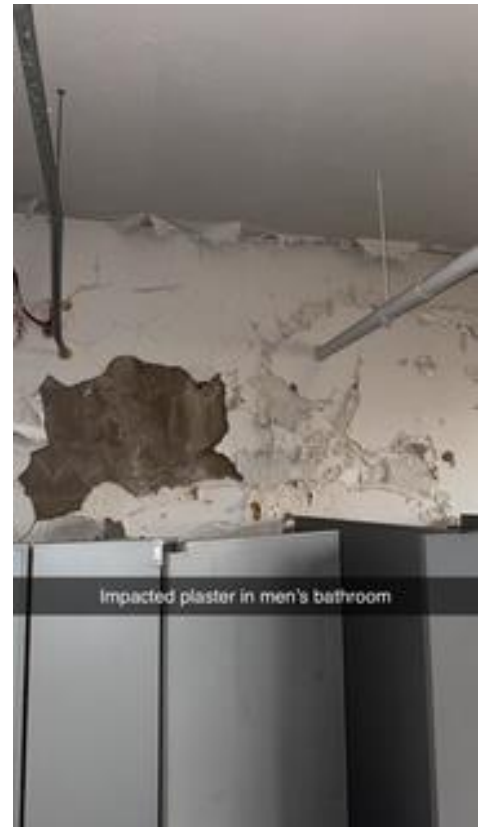
Impacted plaster in men's bathroom

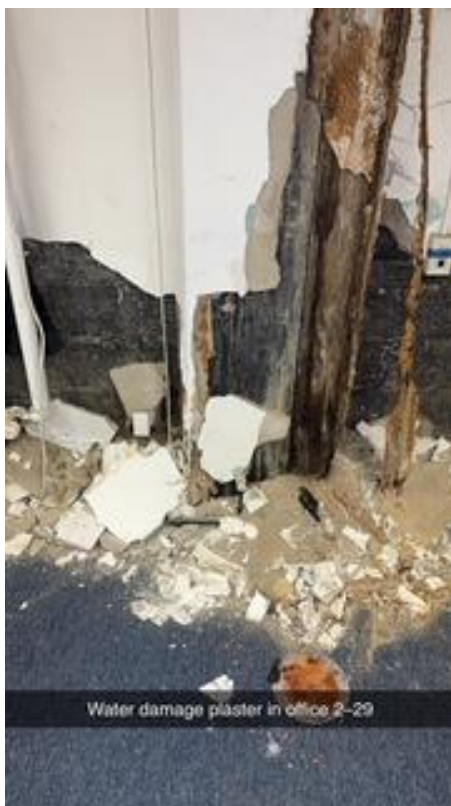
Water damage plaster in office 2-29

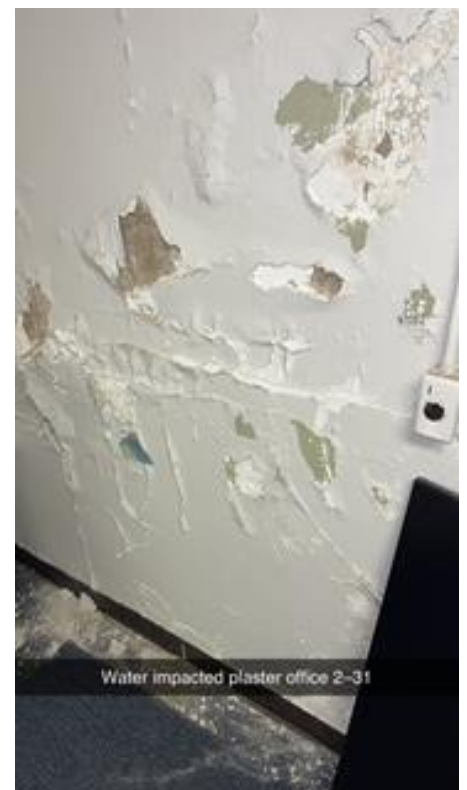
Water impacted plaster office 2-31

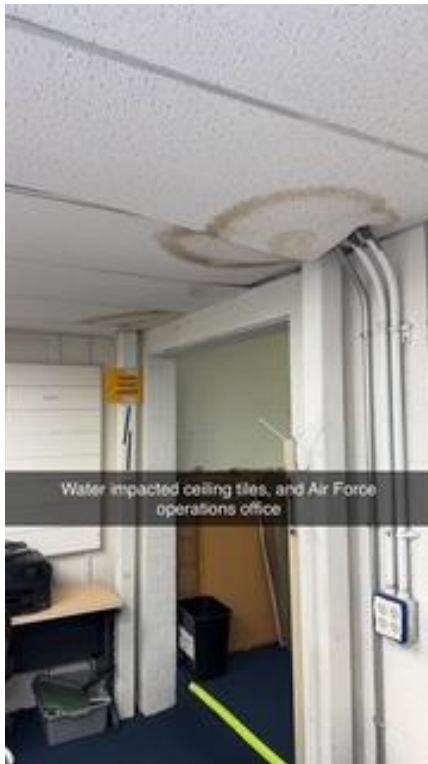
Water impacted ceiling tiles, and Air Force operations office

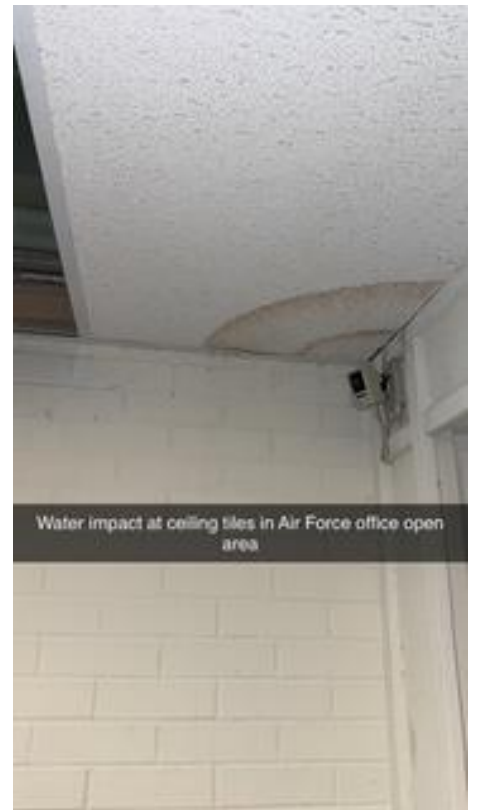
Water impact at ceiling tiles in Air Force office open area

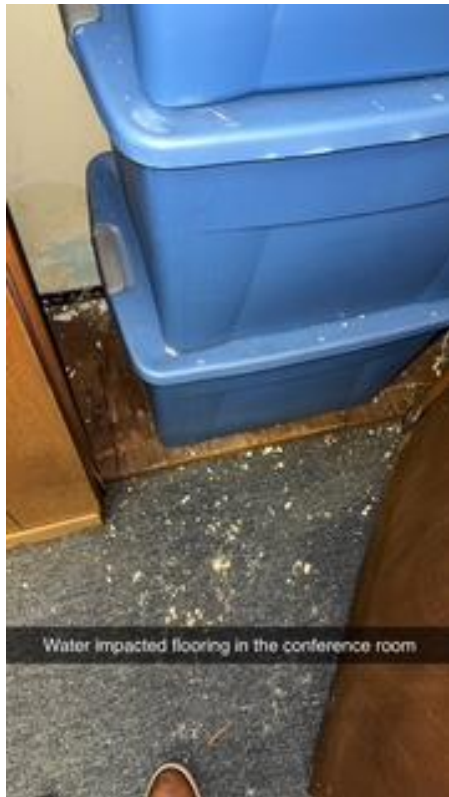
Water impacted flooring in the conference room

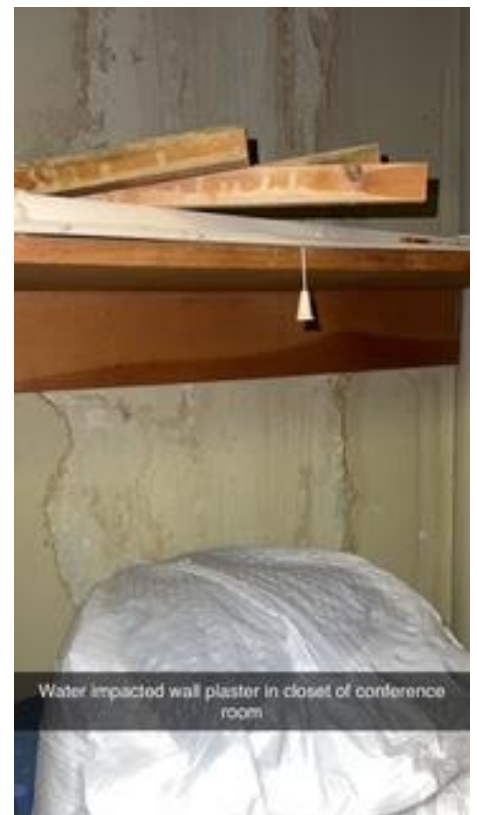
Water impacted wall plaster in closet of conference room
