# **Hazmat Survey Report for the Kensico Laboratory, Rev. 1**

**In support of  
Contract CAT-423**

**May, 2018**

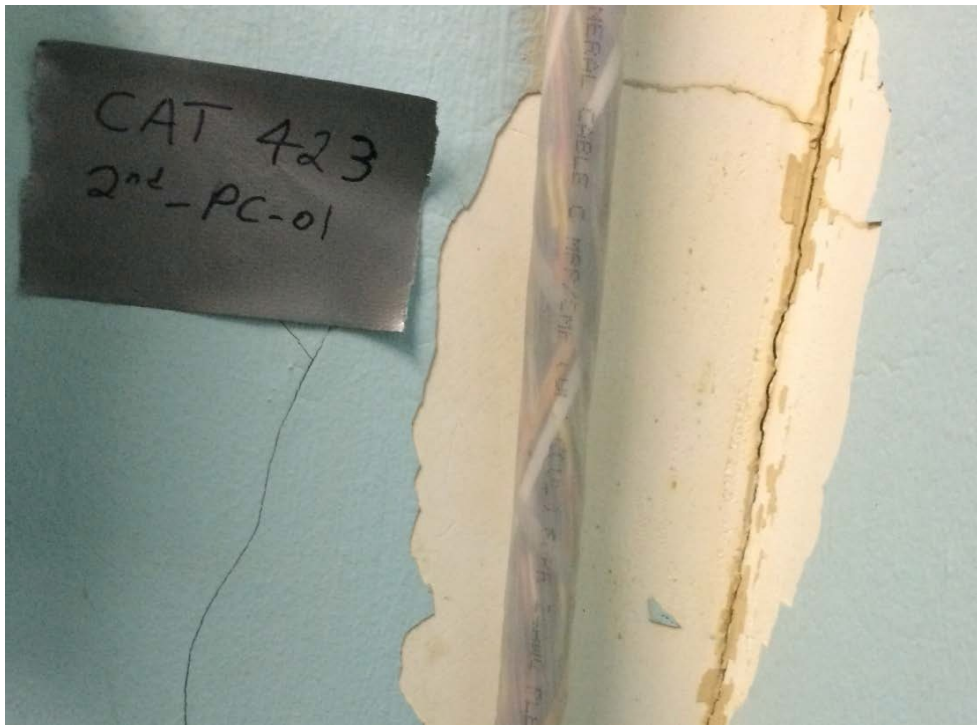
**Picture 1. Lead-based and PCB-containing blue over beige wall paint in the Second Floor, Library and Conference Room (CAT423-2ND-PC-01).**

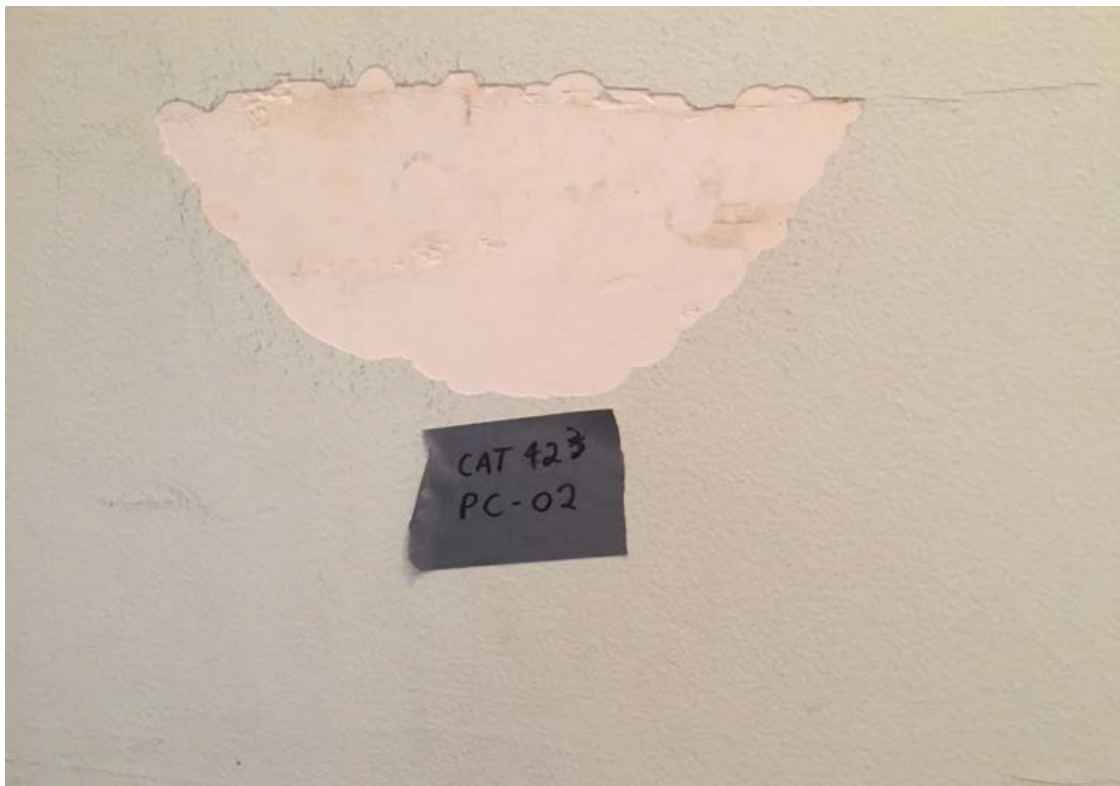
**Picture 2. Lead and PCB-containing green wall paint in the Second Floor, Hallway (CAT423-2ND-PC-02).**

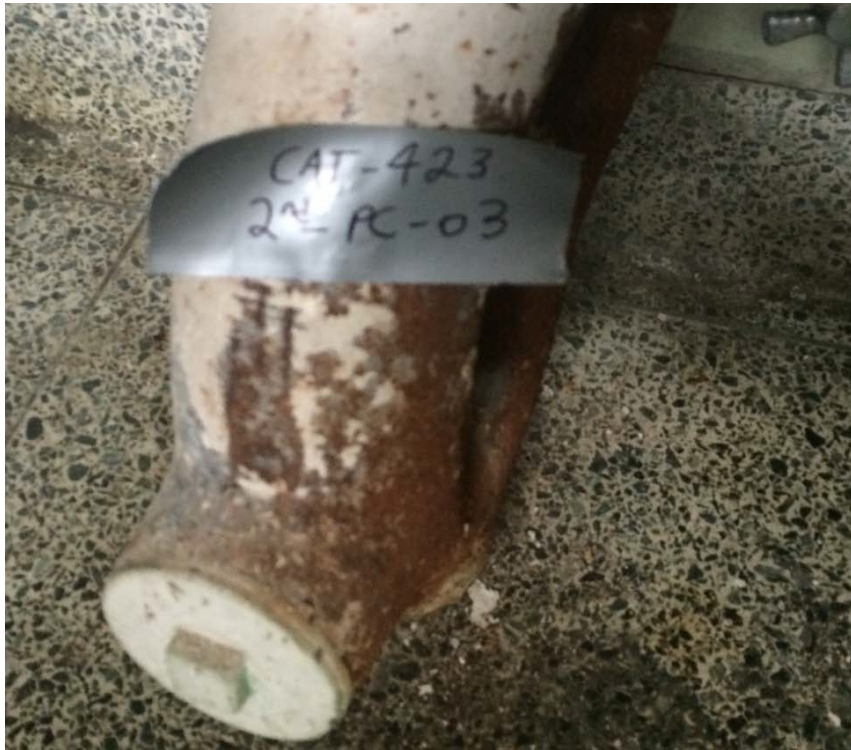
**Picture 3. Lead and PCB-containing white sink drain paint in the Second Floor, Men's Bathroom (CAT423-2ND-PC-03).**

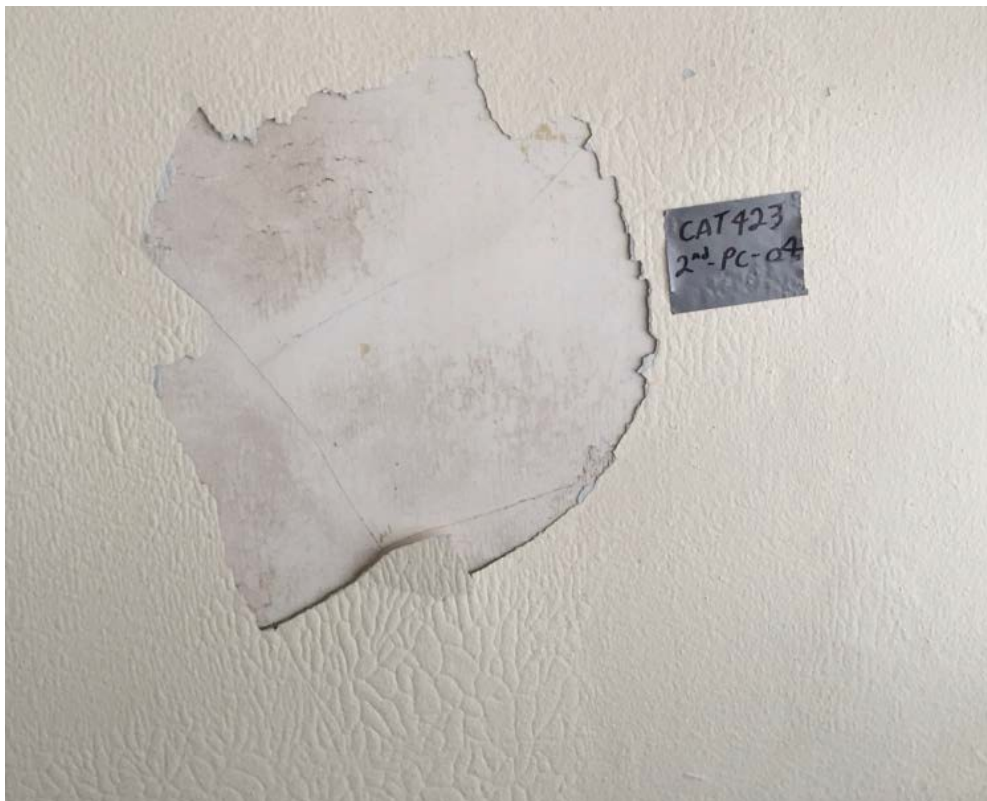
**Picture 4. Lead and PCB-containing beige over blue wall paint in the Second Floor, Watershed Division Engineer's Office (CAT423-2ND-PC-04).**

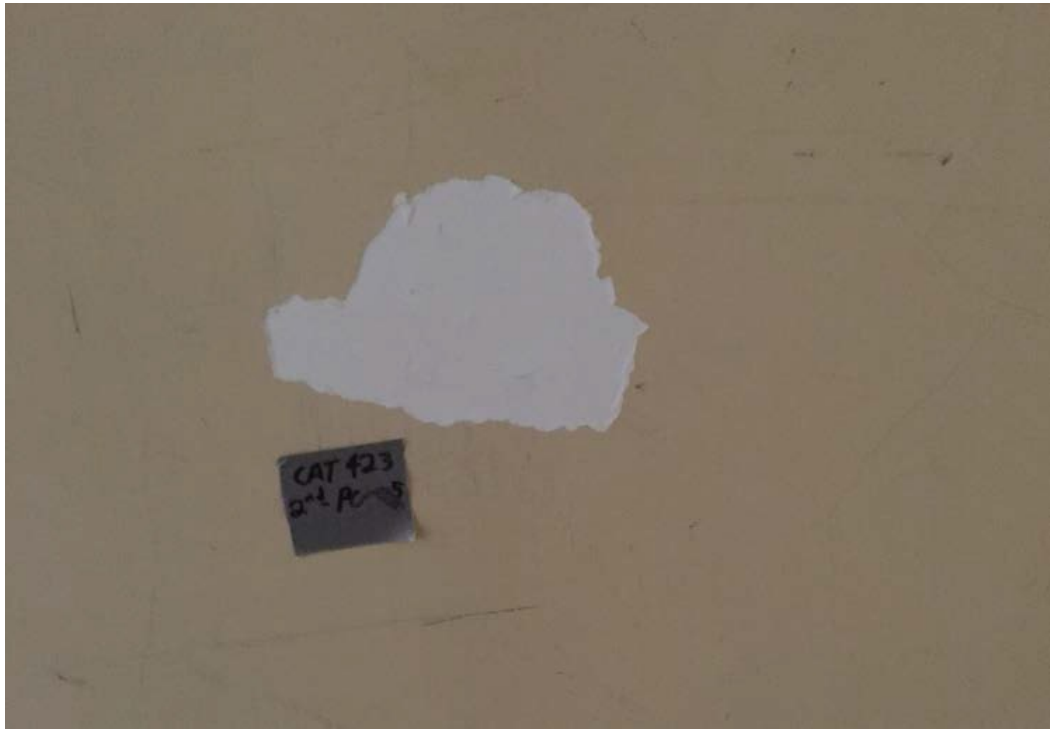
**Picture 5. Lead and PCB-containing yellow wall paint in the Second Floor, Watershed Engineer's Office closet (CAT423-2ND-PC-05).**

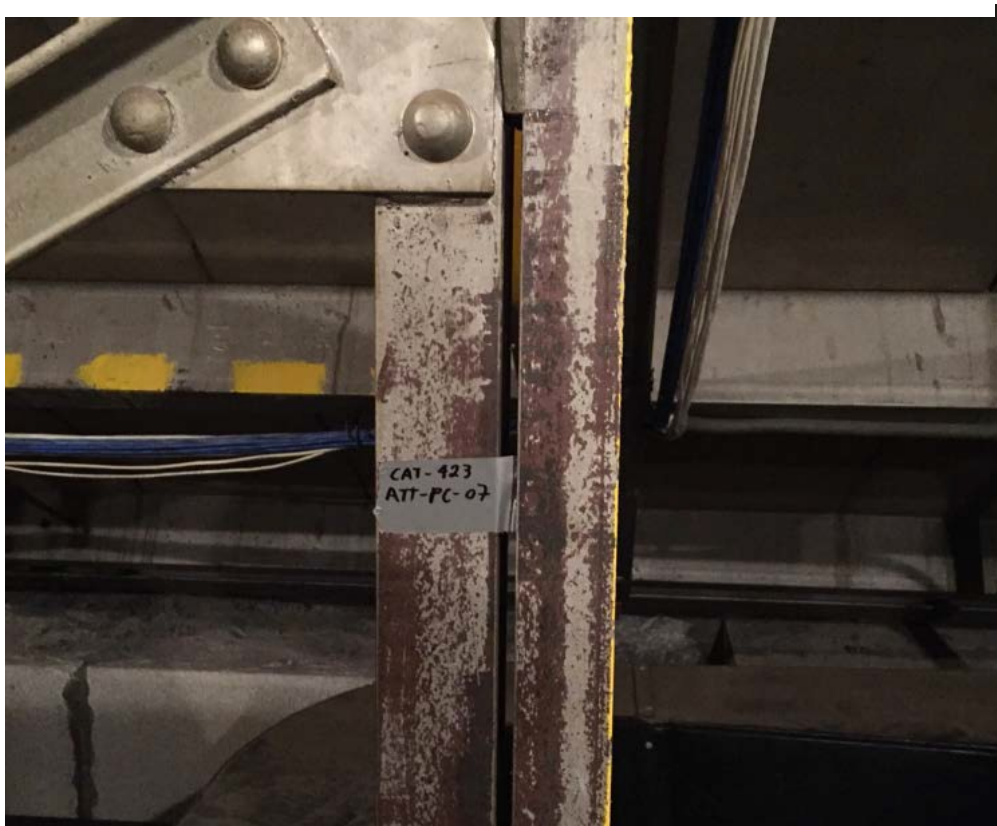
**Picture 6. Lead-based and PCB-containing silver framework paint in the Attic (CAT423-ATT-PC-07).**

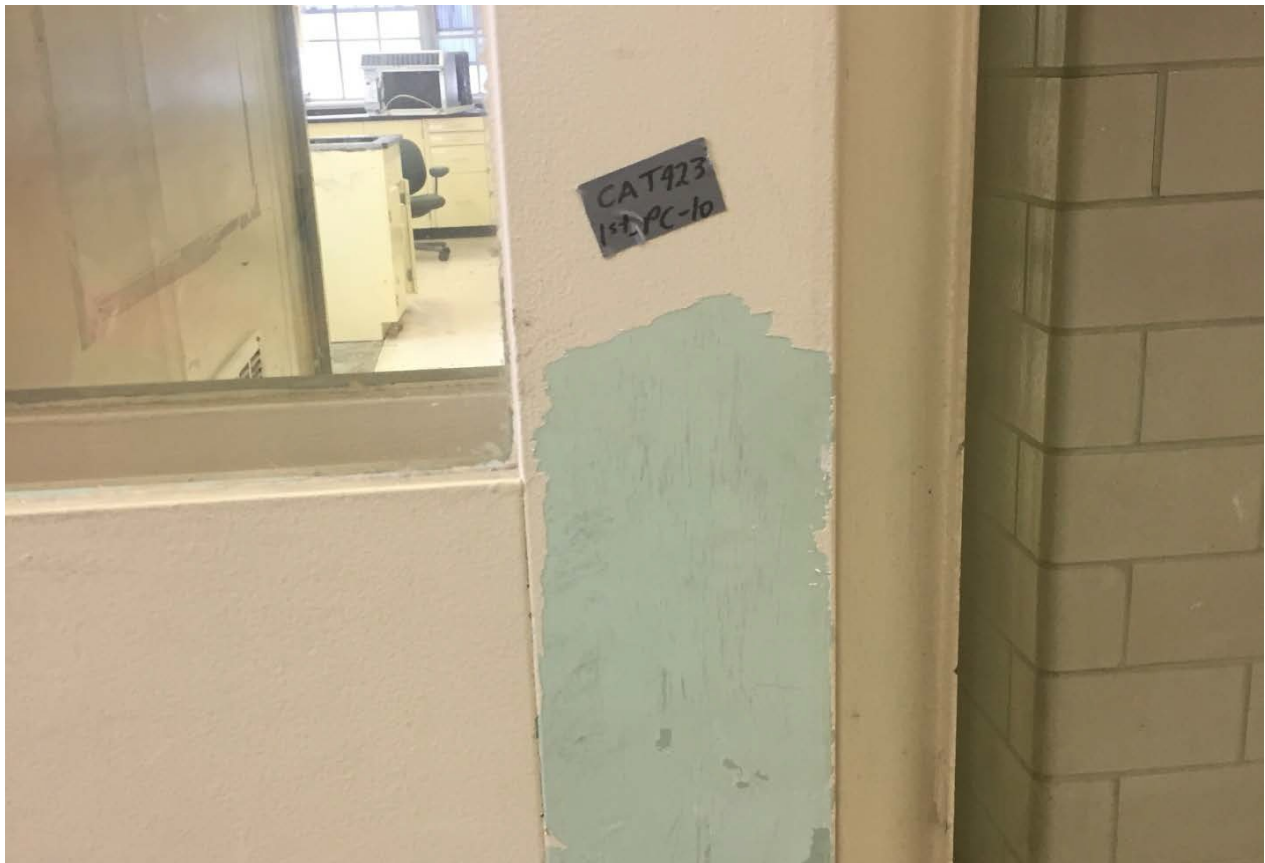
**Picture 7. Lead and PCB-containing beige over green door paint in the First Floor, Office (CAT423-1ST-PC-10).**

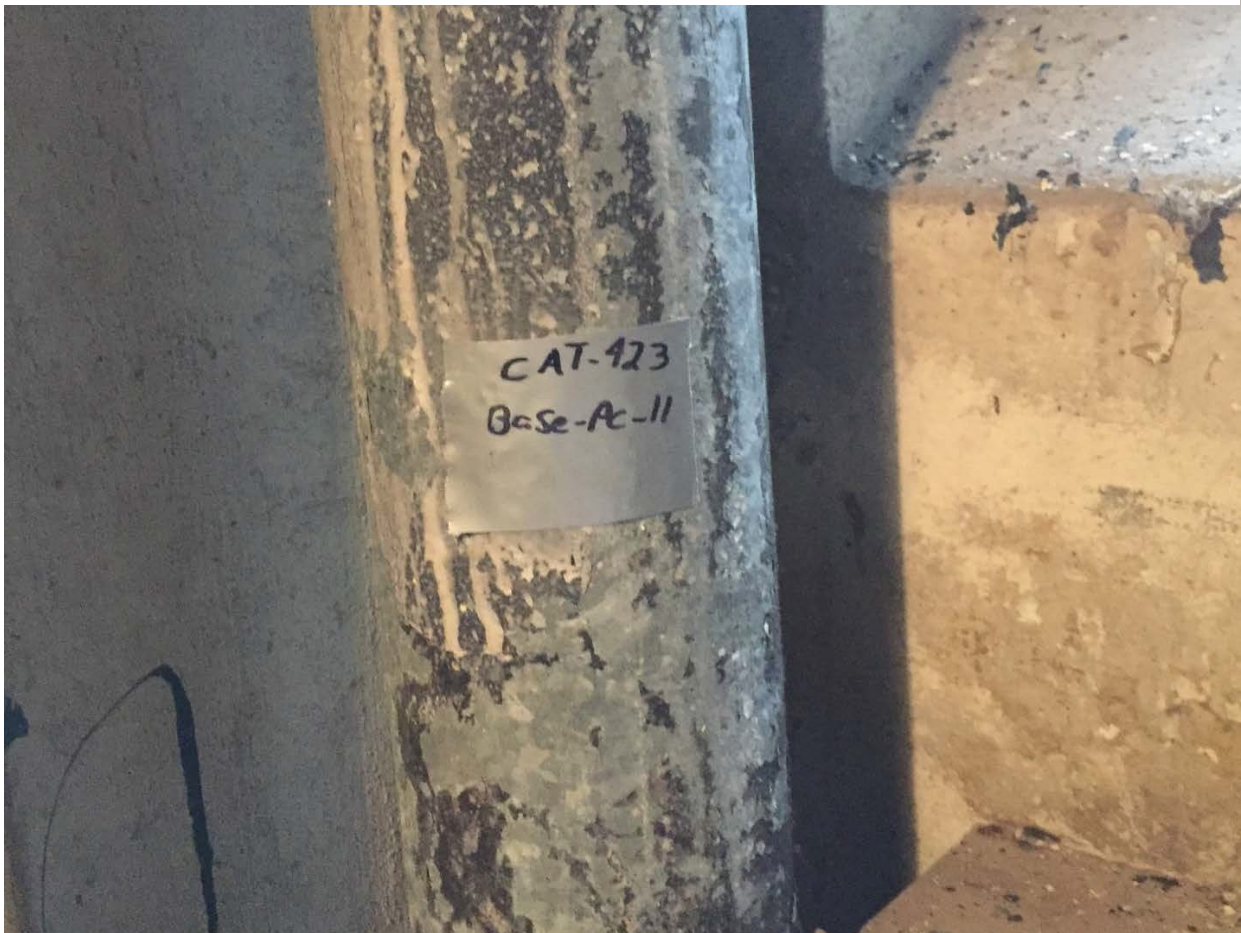
**Picture 8. Lead and PCB-containing black drain pipe paint in the Basement, Boiler Room (CAT423-BASE-PC-11).**

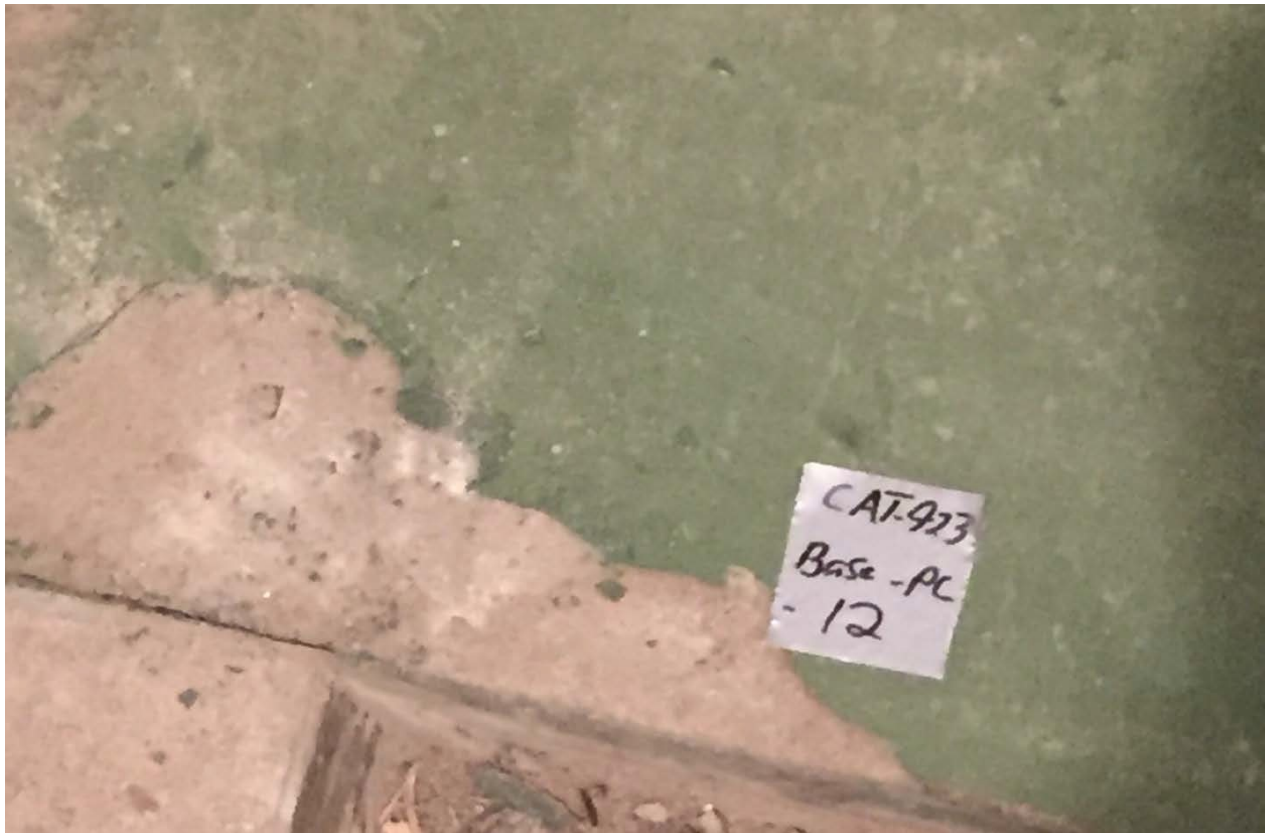
Picture 9. Lead and PCB-containing green floor paint in the Basement, Storage Room (CAT423-BASE-PC-12).

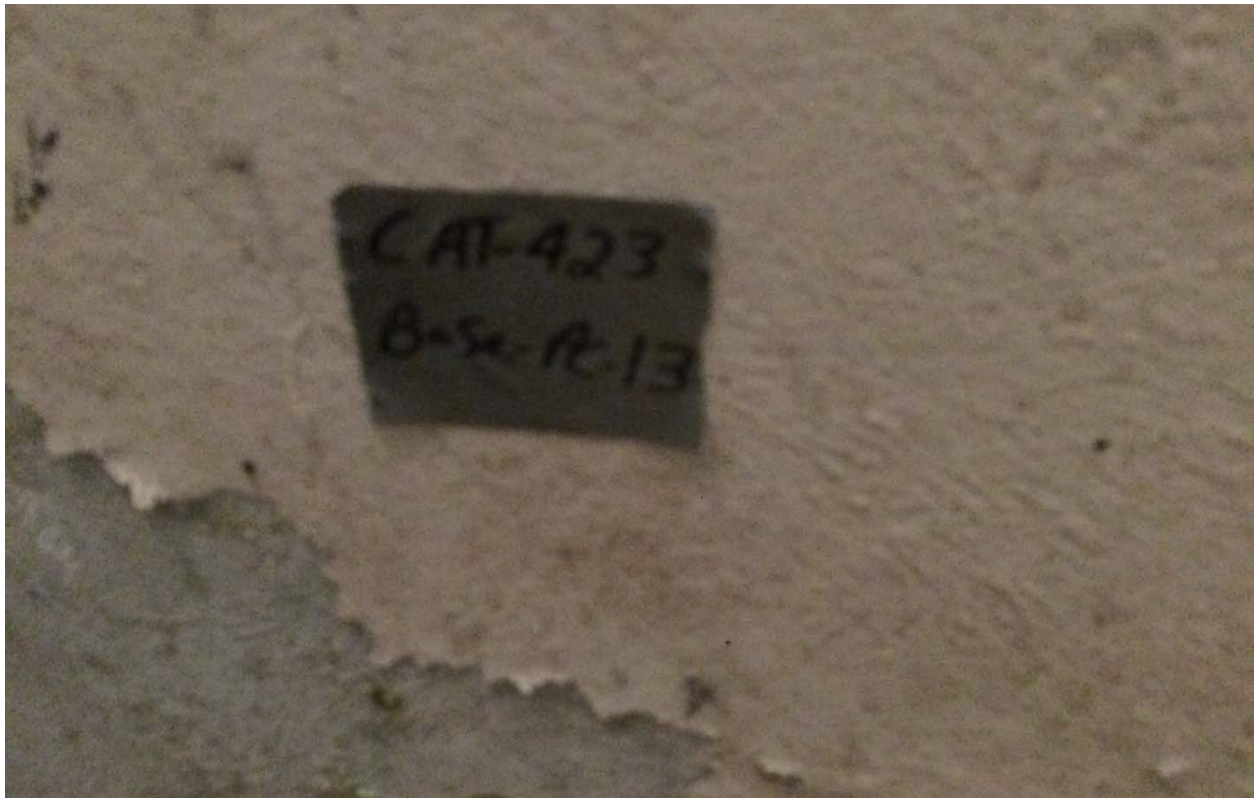
Picture 10. Lead-based and PCB-containing white wall paint in the Basement, Hallway (CAT423-BASE-PC-13).

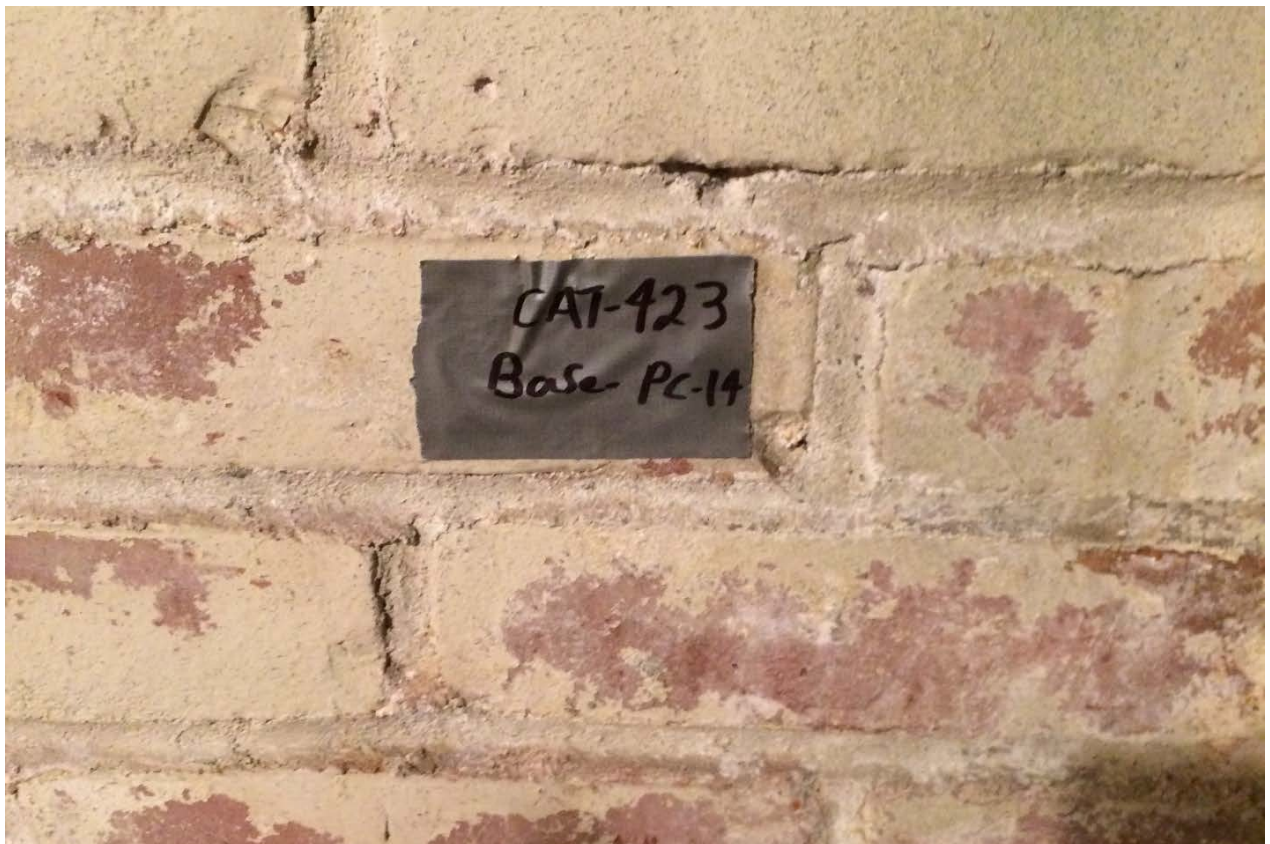
Picture 11. Lead-based and PCB-containing beige wall paint in the Basement, Storage Room (CAT423-BASE-PC-14).

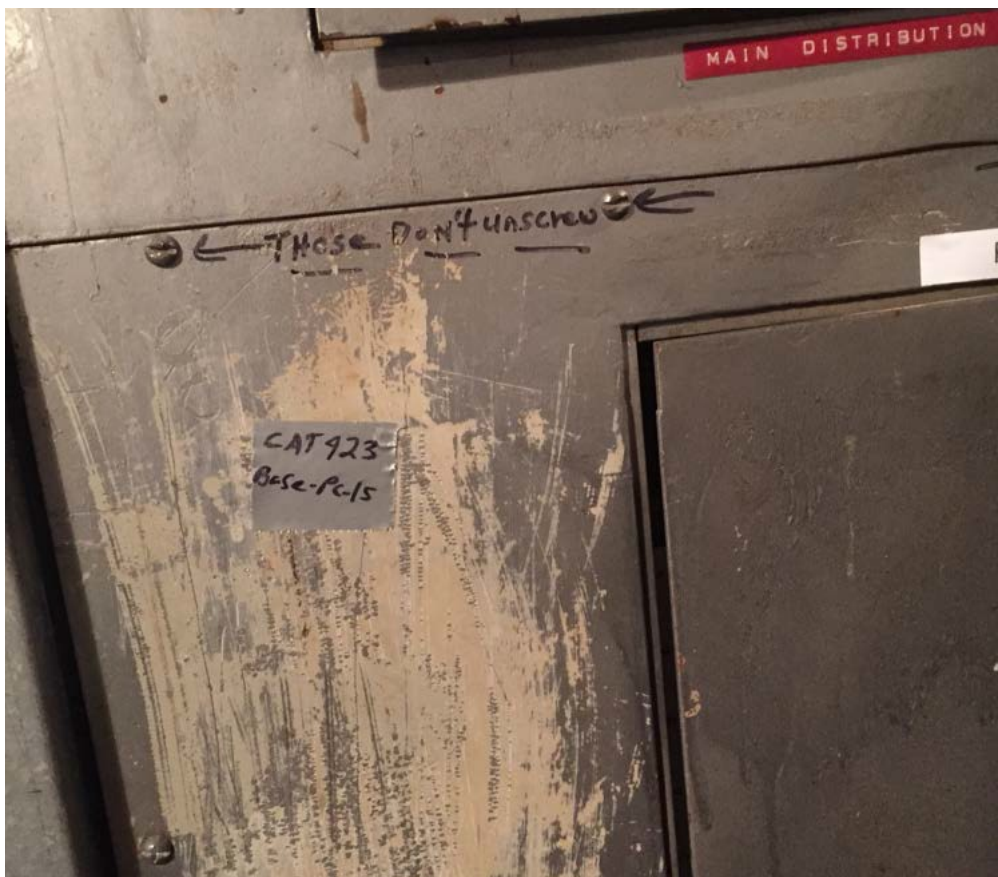
Picture 12. Lead and PCB-containing silver electrical panel paint in the Basement, Boiler Room (CAT423-BASE-PC-15).

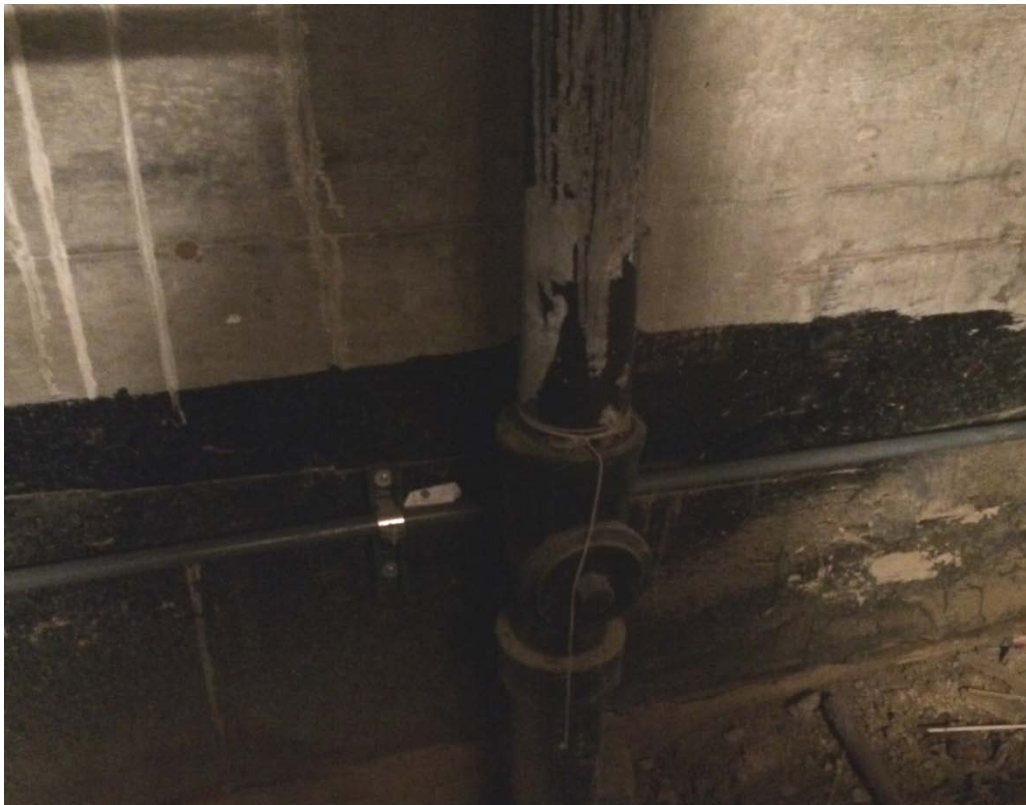
**Picture 13. Lead-based and TSCA-regulated PCB black drain pipe paint in the Basement, Crawlspace (CAT423-BASE-PC-18).**

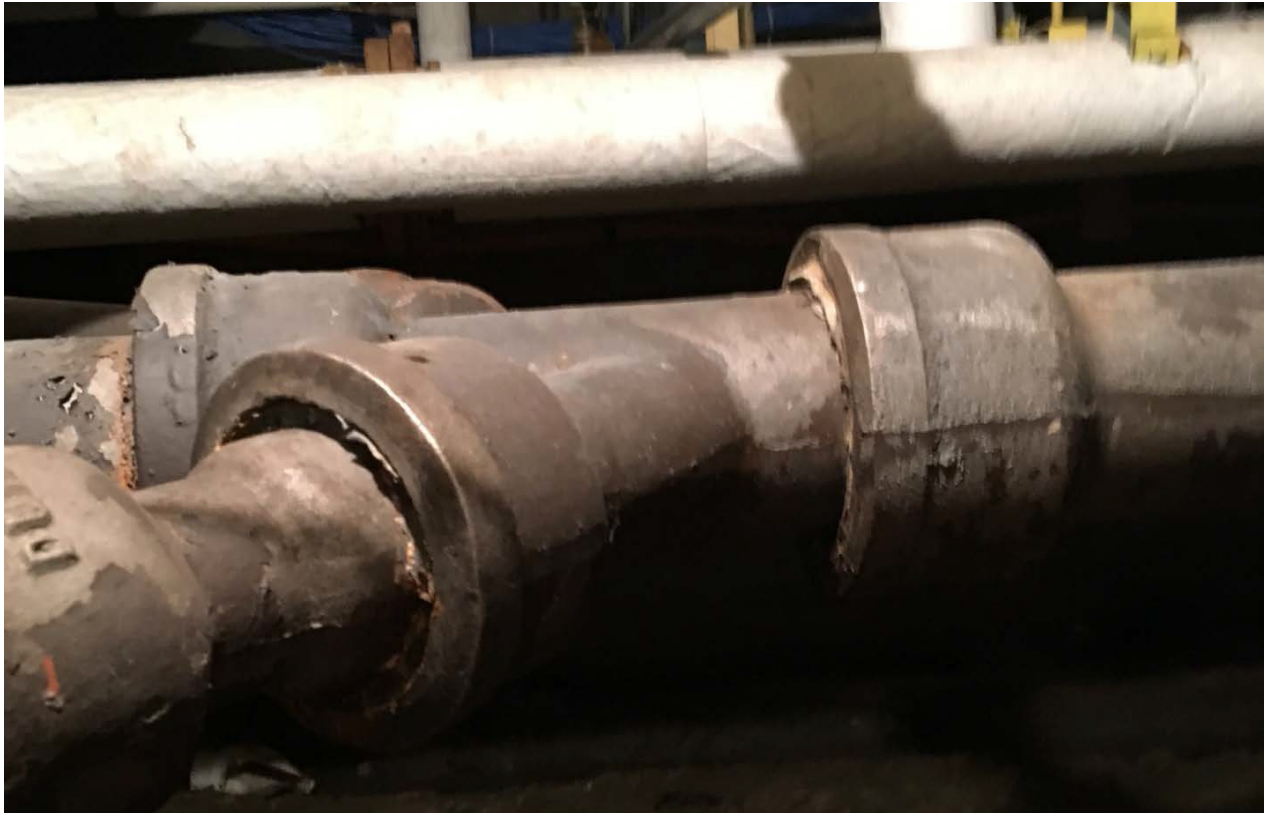
**Picture 14. Lead-based and TSCA-regulated PCB brown drain pipe paint in the Basement, Crawlspace (CAT423-BASE-PC-19).**

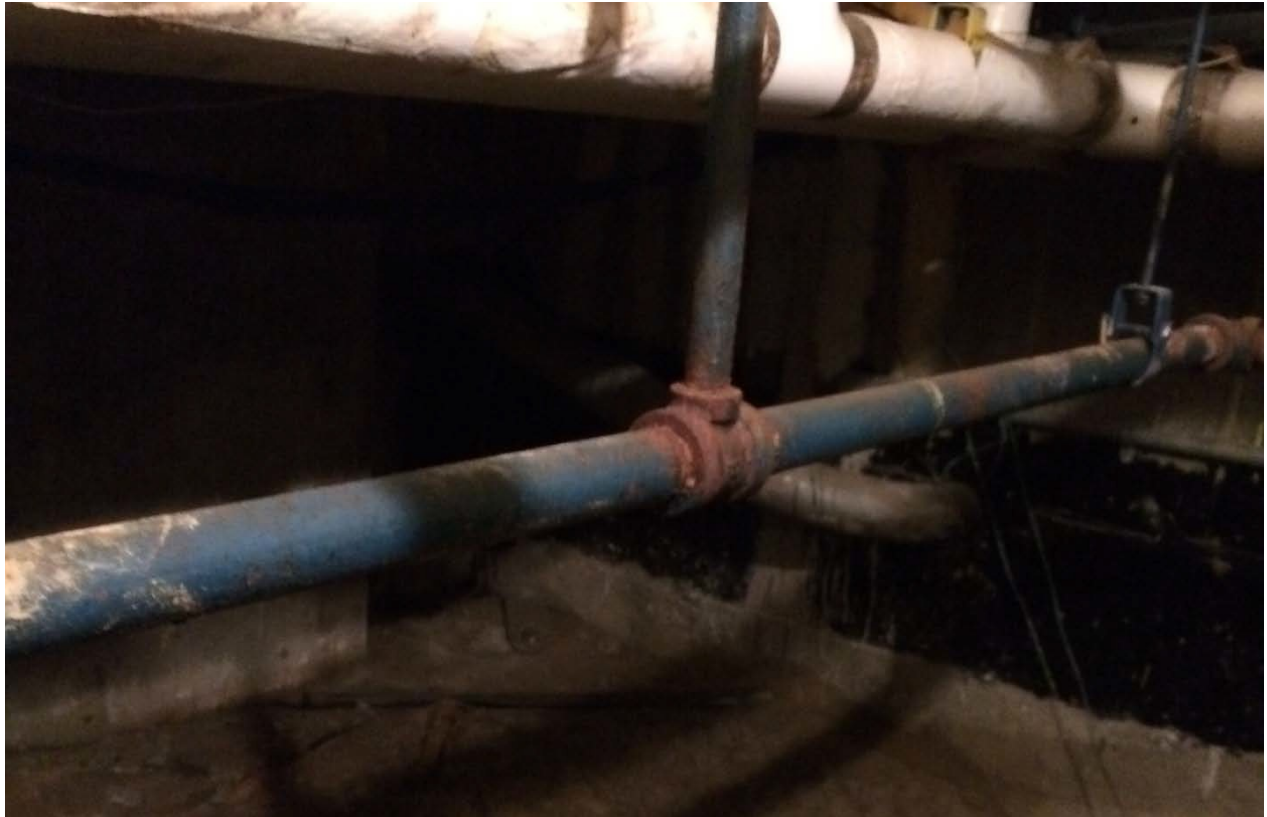
**Picture 15. Lead-based and TSCA-regulated PCB blue pipe paint in the Basement, Crawlspace (CAT423-BASE-PC-20).**

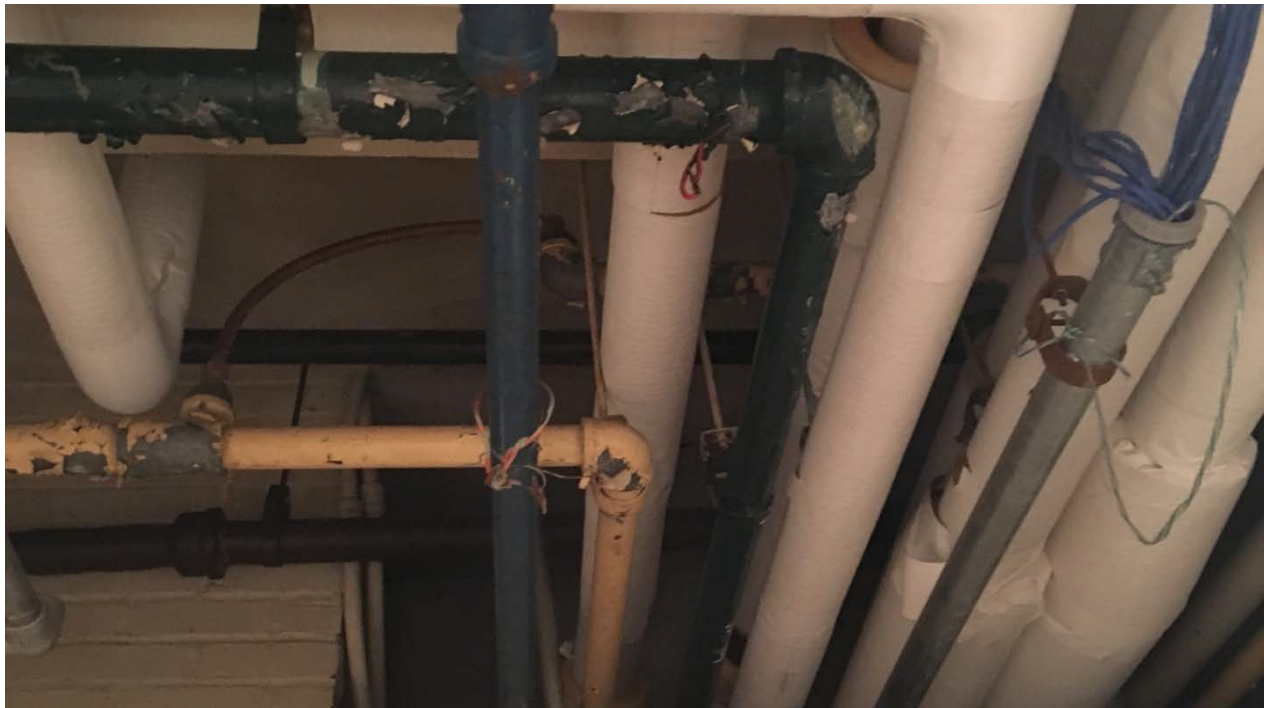
**Picture 16. Lead-based and TSCA-regulated PCB green and yellow paints on pipes in the Basement, Storage Room (CAT423-BASE-PC-21,22).**

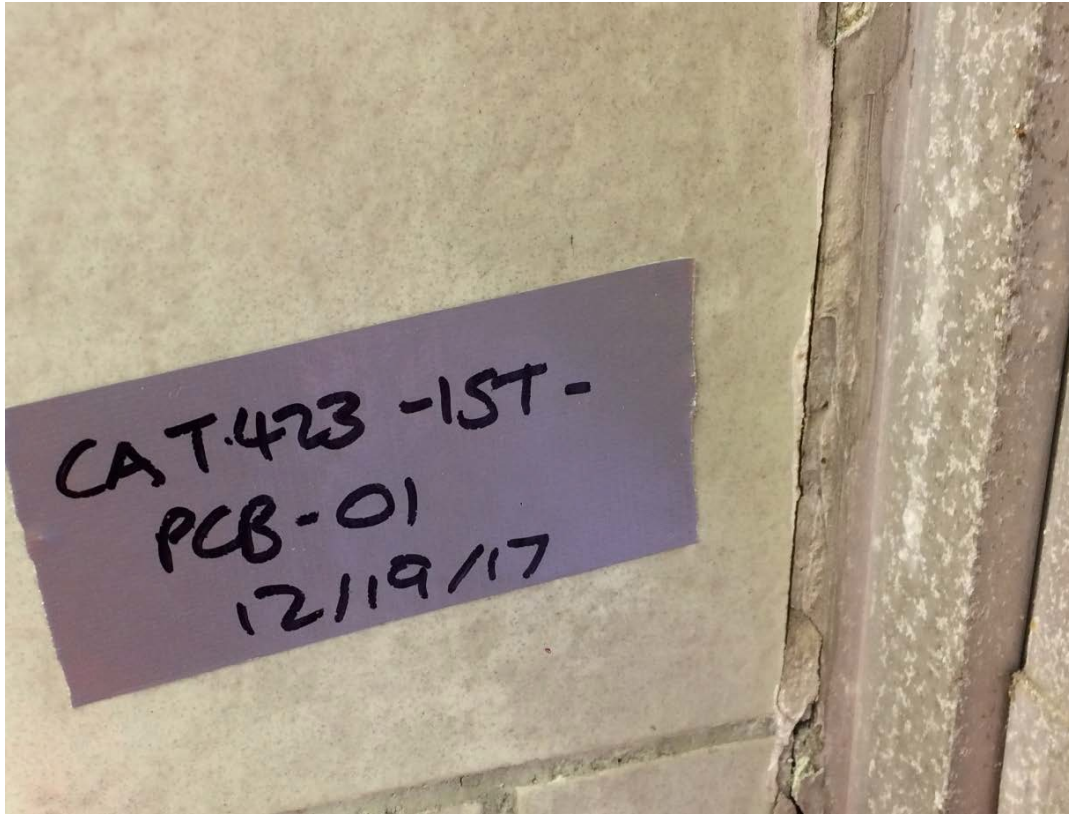
Picture 17. PCB-containing caulk around the interior window of the First Floor, General Lab (CAT423-1ST-PCB-01).

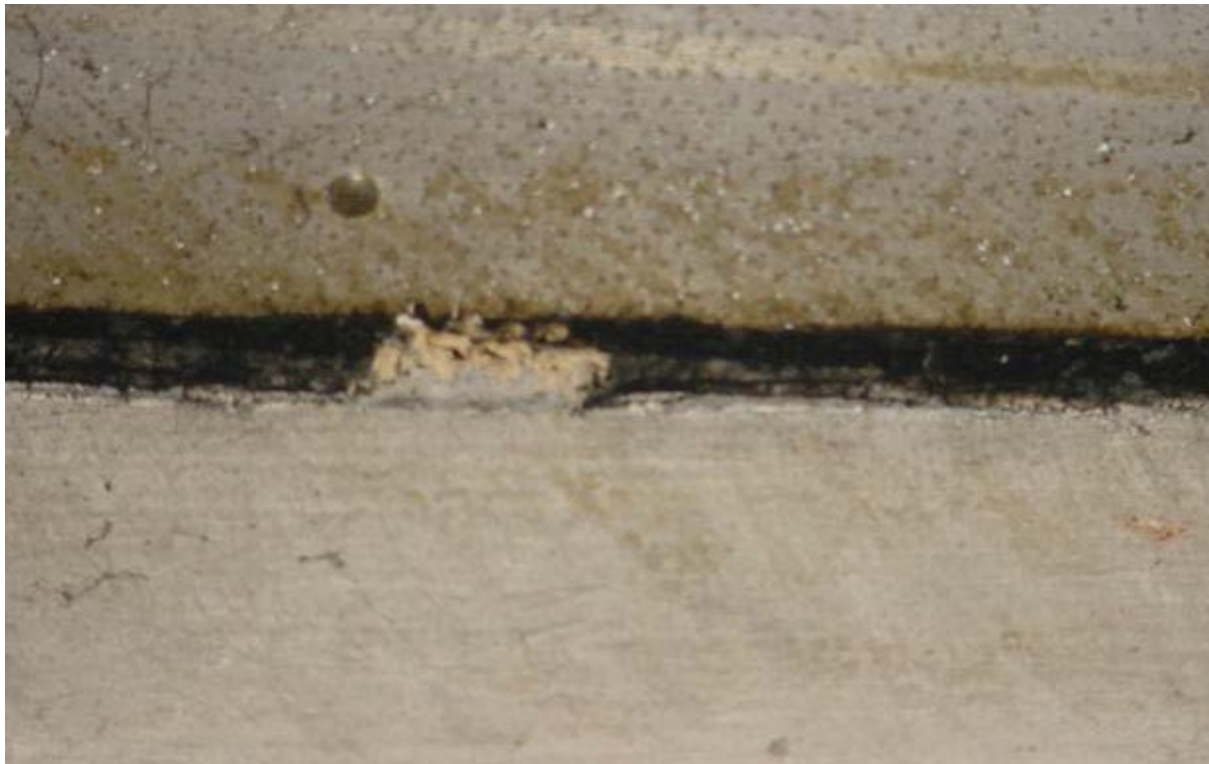
Picture 18. PCB-containing caulk around the Basement, Boiler Room door (CAT423-BASE-PCB-02).

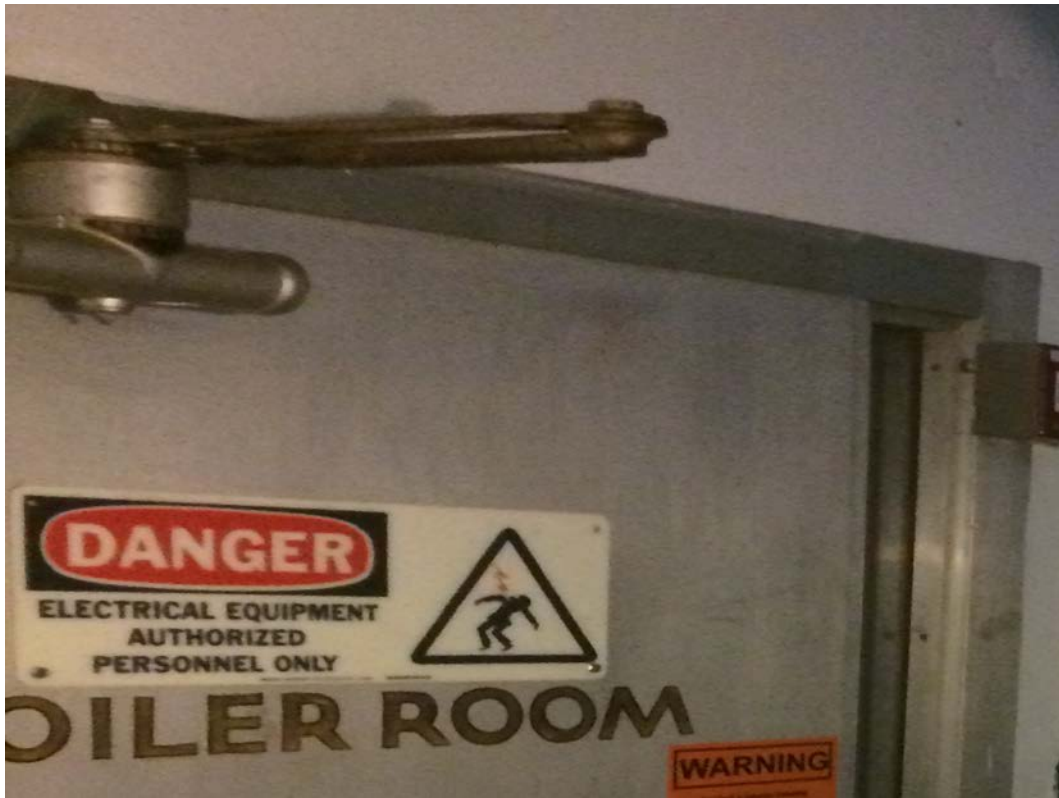
Picture 19. Door Closer with PCB-containing oil on Basement, Boiler Room Door (CAT423-1ST-PCB-11)

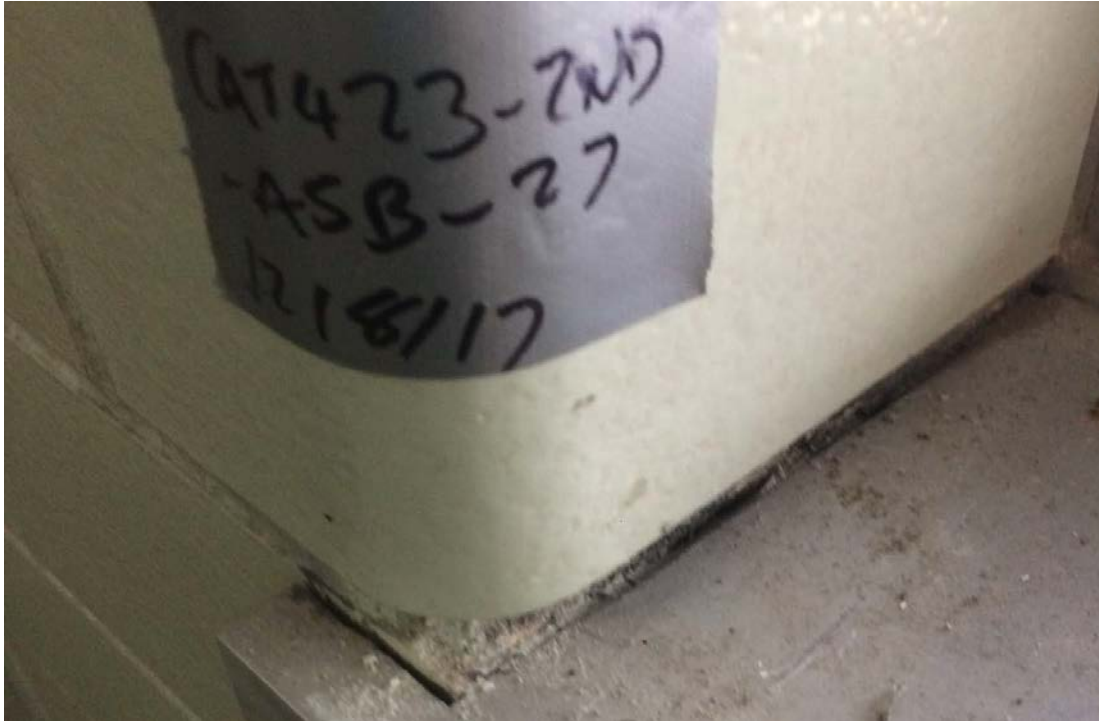
Picture 20. Asbestos-containing black caulk on the radiators in the Second Floor, Men's and Women's Bathrooms (CAT423-2ND-ASB-26,27).

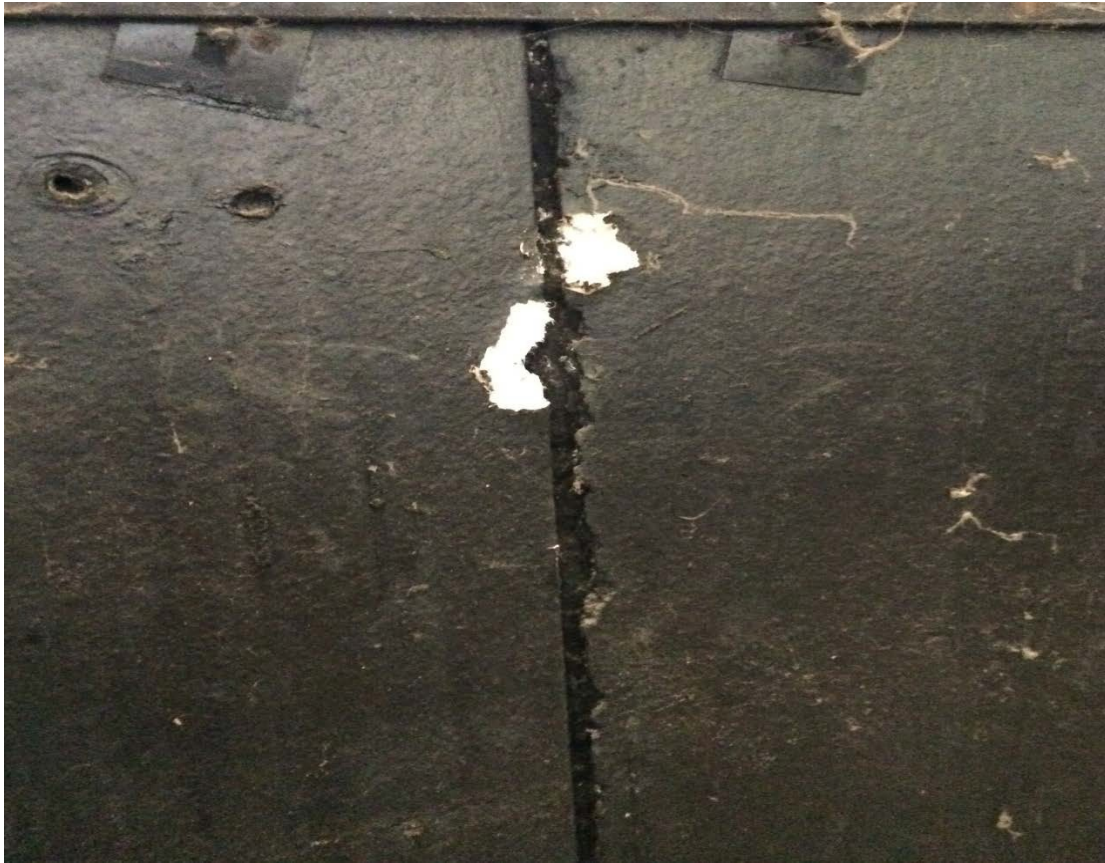
**Picture 21. Asbestos-containing black radiator shielding in the Second Floor, Stairwell (CAT423-2ND-ASB-28,29).**

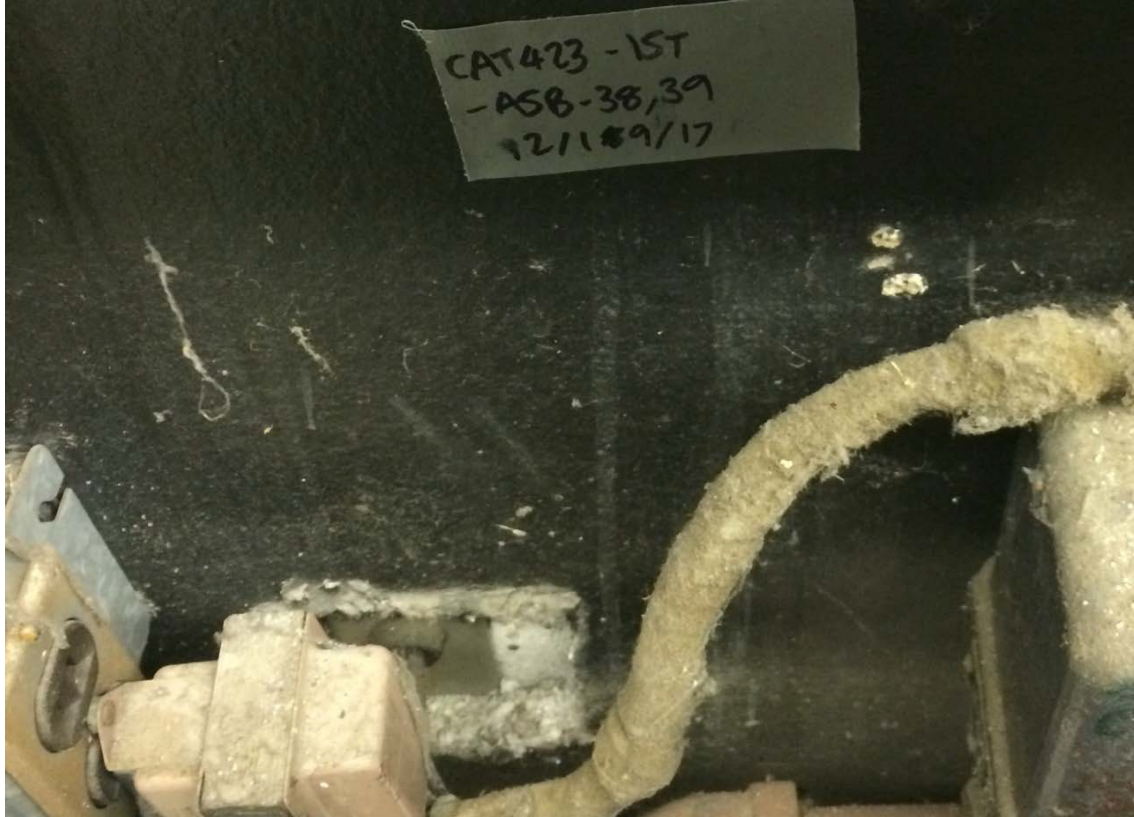
**Picture 22. Asbestos-containing brown canvas wire wrap in the radiator of the First Floor, General Lab (CAT423-1ST-ASB-38,39).**

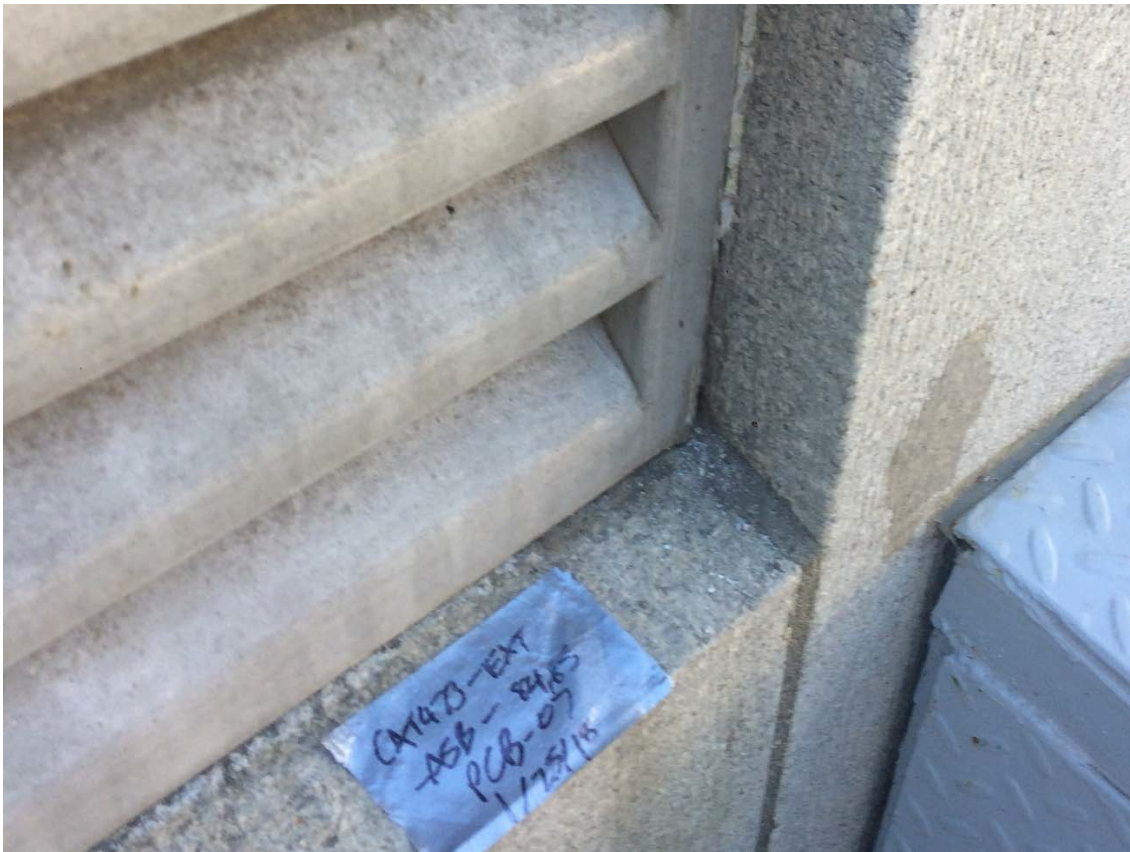
Picture 23. Asbestos-containing white caulk around Exterior, South Wall vent (CAT423-EXT-ASB-84,85).

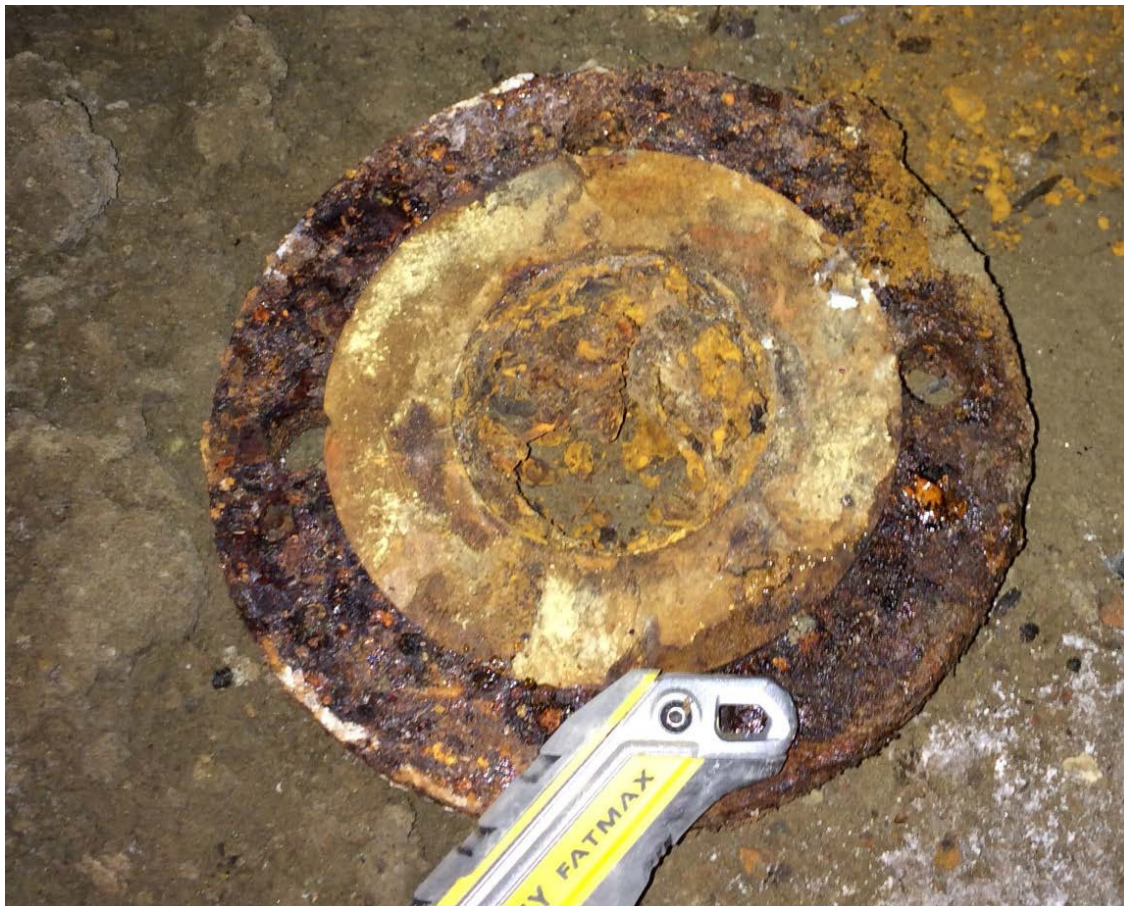
Picture 24. Asbestos-containing brown 4" gasket in the Basement, Crawlspace (CAT423-BASE-ASB-94,95).
