# **Hazmat Survey Report for the Kensico Laboratory, Rev. 1**

**In support of  
Contract CAT-423**

**May, 2018**

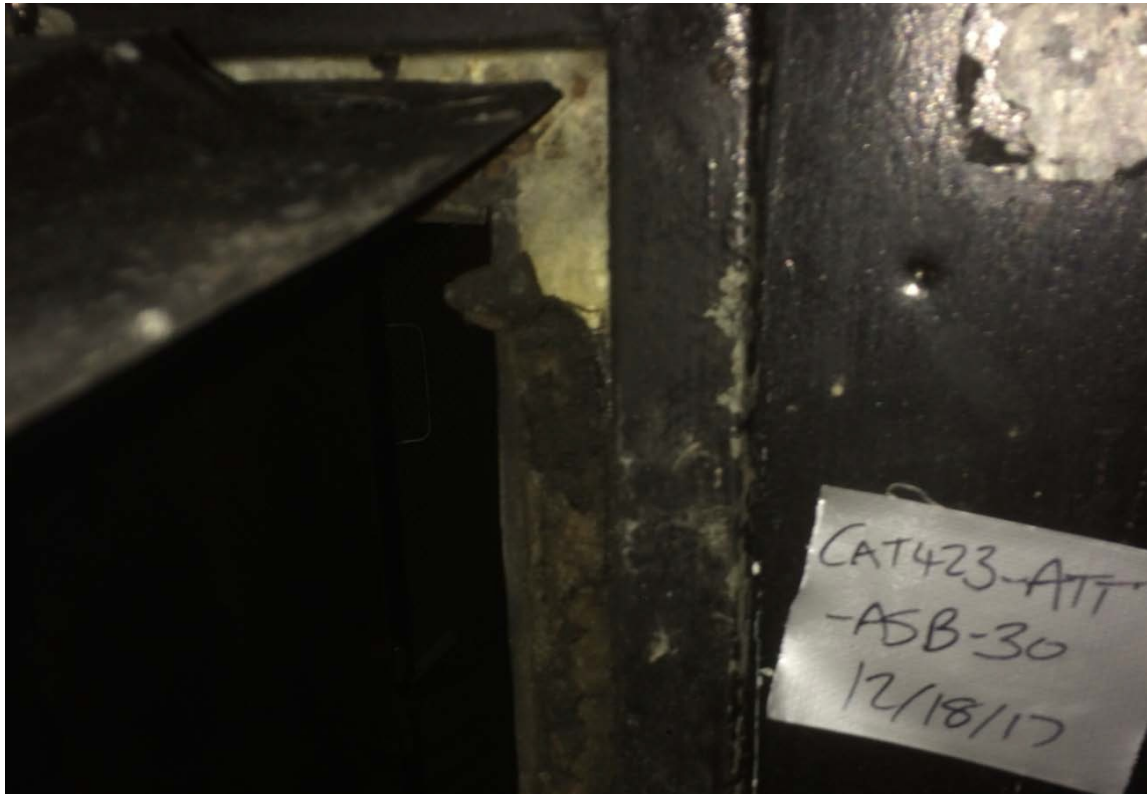
Picture 25. Gasket in Attic HVAC unit containing trace asbestos (CAT423-ATT-ASB-30).
