# BULLETIN # 0 2

**PROJECT:** Harrison Recreation & Community Center – PHASE 2  
Harrison, NY

**RE:** Geotechnical Revisions

Re: Recommendations following 2-4-2025 Field Visit  
Harrison Recreation Center, 270 Harrison Avenue  
Harrison, NY

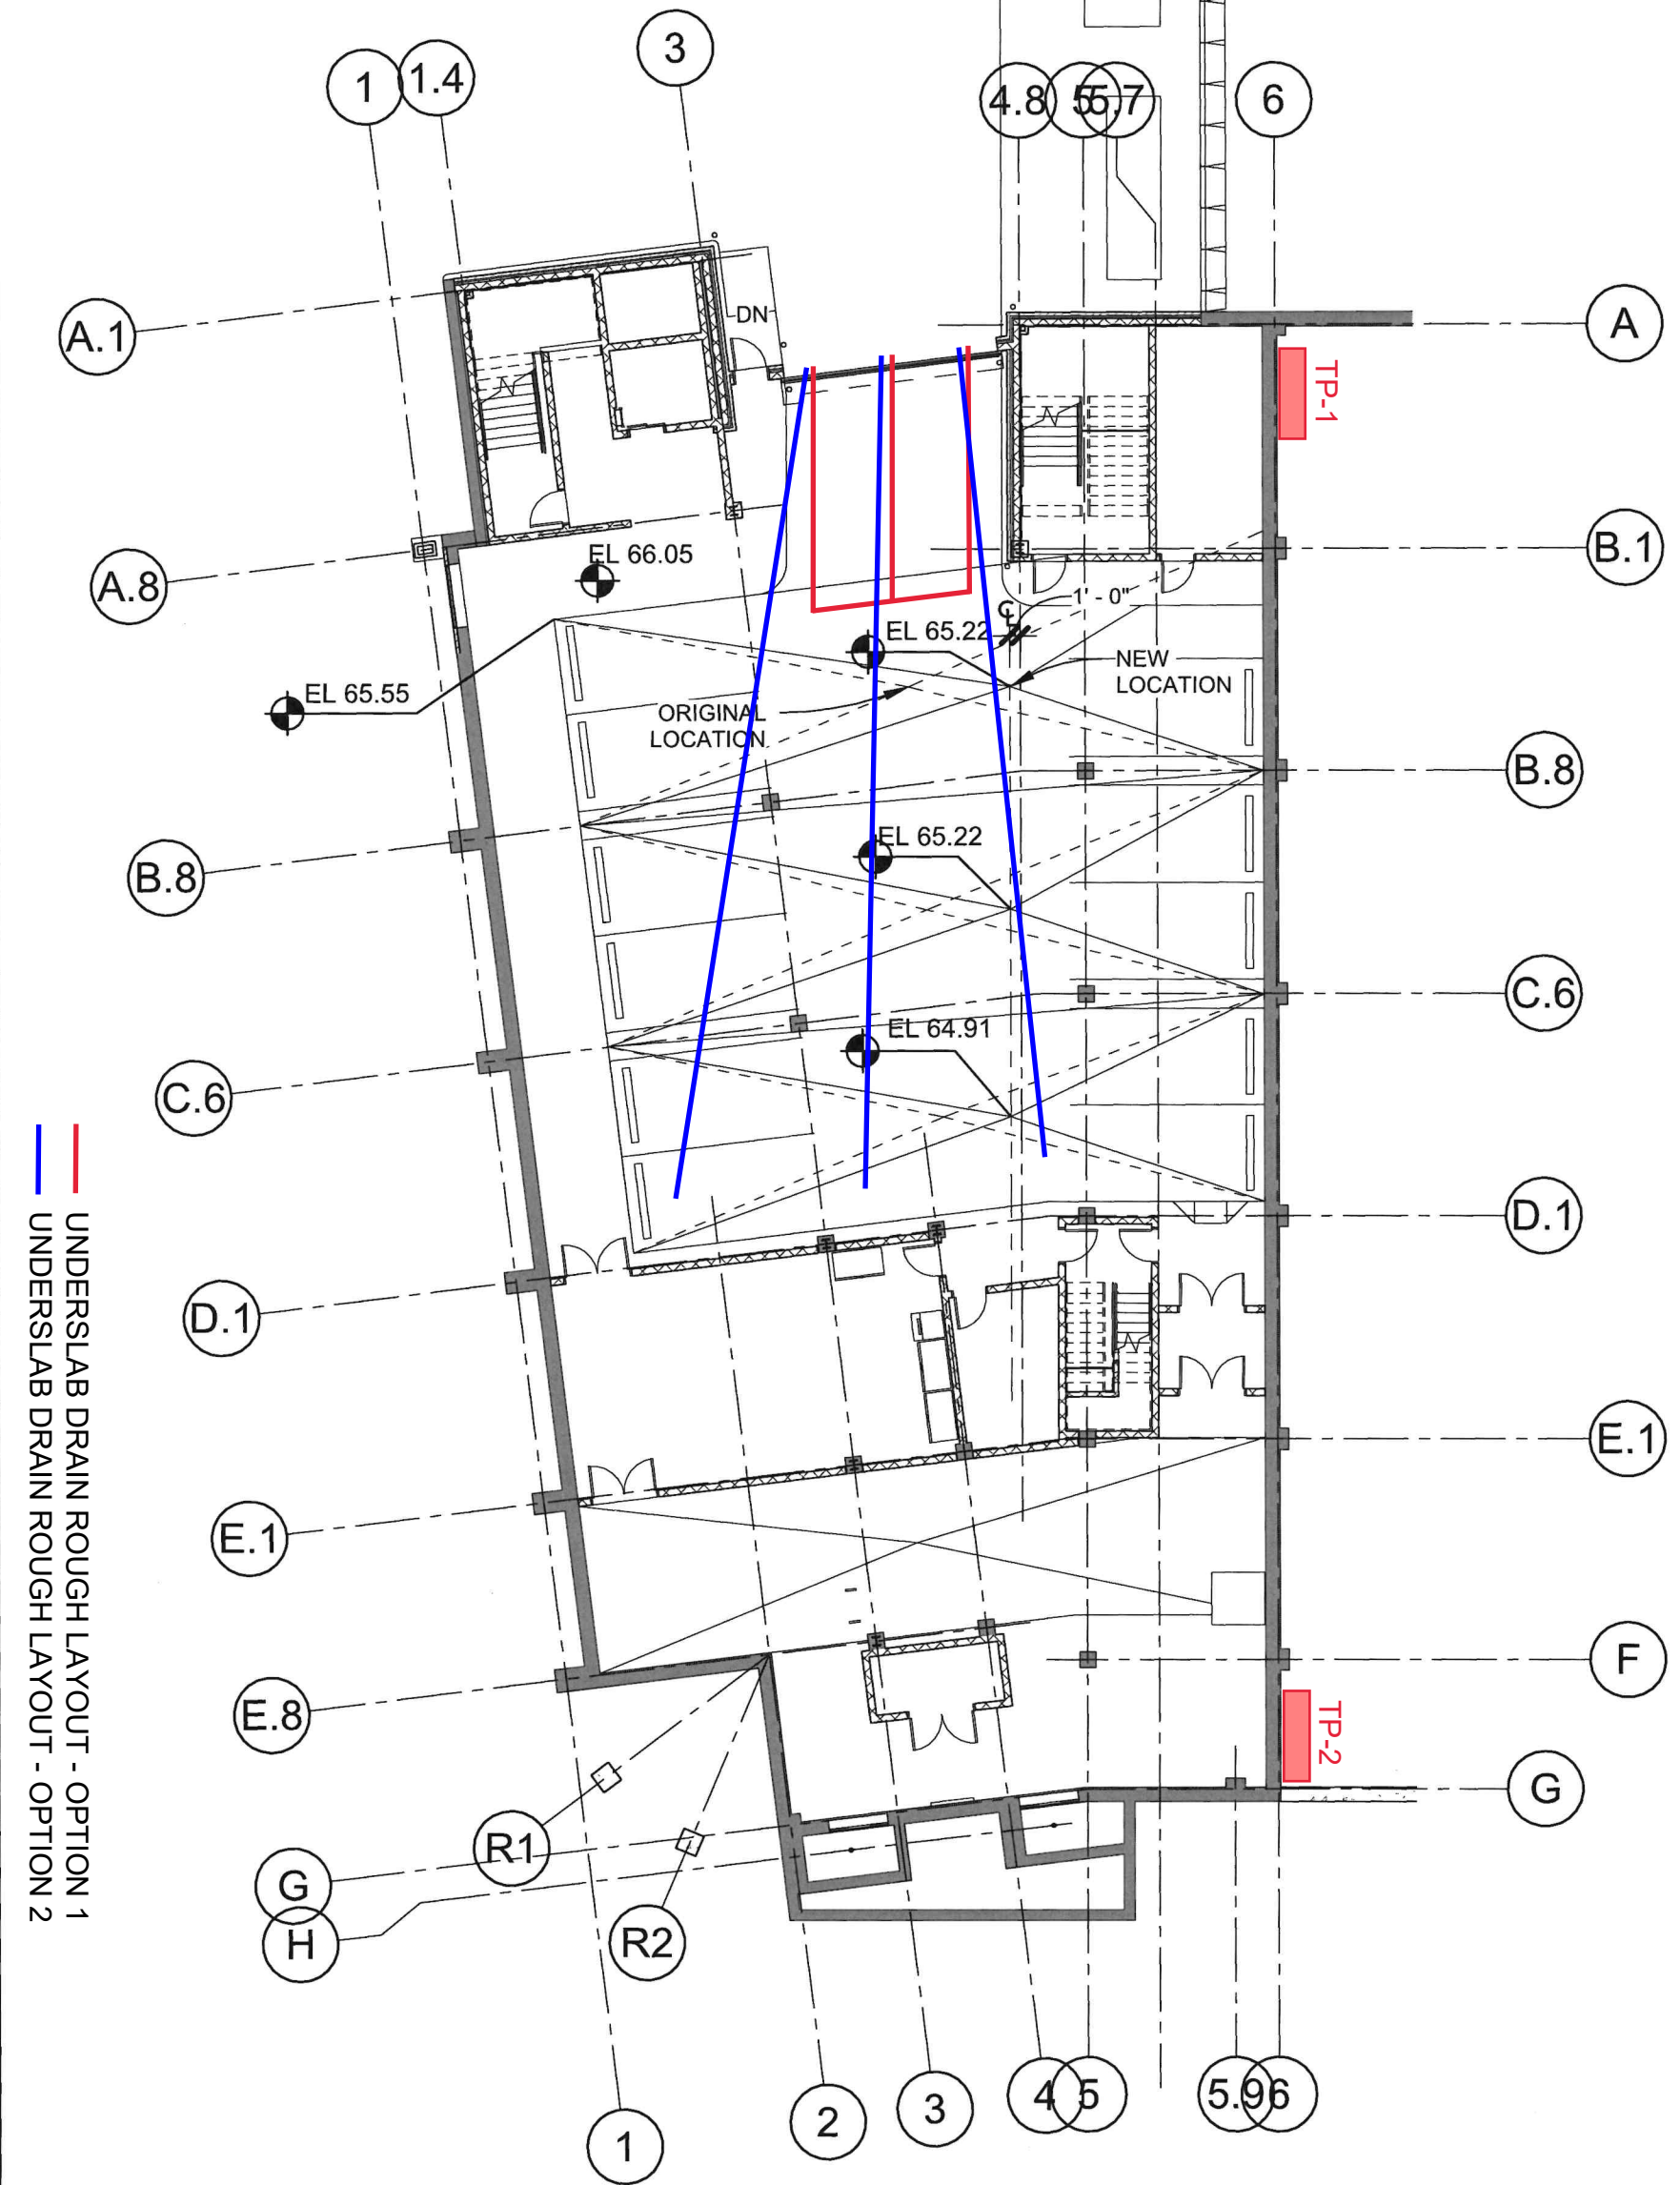
Sheet Title	Job No.	Sheet No.
BASEMENT DRAINAGE	2020-1005	ASK-2
	Date	
S.E.D. Control No.	1/24/2025	Reference Drawing:
	Scale	
	1/16" = 1'-0"

The attached ASK-02 illustrates the revised under slab drainage configuration. Please proceed with Option 2 as shown on ASK-02. The attached letter provides descriptions of the materials.

We reviewed the current conditions in the garage area and discussed the slab being raised here approximately 1 ft. Considering the amount of underground utilities that need to fit within the stone layer below the slab, and the fact that the stone itself will act as a suitable conduit for groundwater removal, we are revising our previous recommendations to greatly reduce the number and extent of the underslab drain pipe network. We now recommend three (3) drain pipes be installed through the side wall of the trench drain at the garage entrance and either be connected in manifold-formation 10 ft. to 20 ft. into the garage (as space allows), or be splayed into the garage area (as space allows) and dead-ended. The attached sketch illustrates these options. These pipes should be as previously recommended - rigid, 2-hole perforated, smoothwall PVC pipe, either 3 in. or 4 in. diameter (ex. Charlotte PVC 30030P or PVC 30040P, or similar), with the two (2) holes centered facing downward, and be placed level or at a slight pitch towards the trench drain and enclosed in a filter fabric sock.

Lastly, we observed the excavation of two (2) test pits behind (to the north of) the 6-line. Test pit TP-1 was performed along the westernmost  $\pm 8$  ft. of the wall, while test pit TP-2 was performed along the easternmost  $\pm 10$  ft. of the wall, and both pits were excavated to a depth of  $\pm 4$  ft. The small excavator seemed to dig both test pits with relative ease, i.e. it did not struggle at all to penetrate the soils. Both test pits revealed the wall was backfilled with on-site soils along with cobbles ranging in size up to 8 in. to 10 in. diameter at TP-1, and up to 12 in. diameter at TP-2. The soils were very moist and a hand probe penetrated 6 in. to 8 in. vertically into the bottom and 8 in. to 10 in. horizontally into the sidewall of TP-1 at various locations, and 8 in. to 12 in. deep in the bottom of TP-2. Cobbles were observed in contact with the back of the retaining wall and also nested together.

Should a structural solution be considered here, ex. constructing a structural slab to span this area, then we recommend, as a minimum, the top 4 ft. of fill here be removed, the subgrade compacted with a minimum of 8 passes of a vibratory padfoot trench compactor, then Item 4 fill be placed and compacted in maximum 12 in. loose lifts up to required grade. In this manner, some of the future settlement will be mitigated.
