**PRE-DEMOLITION ENVIRONMENTAL SURVEY REPORT
FOR
ASBESTOS-CONTAINING MATERIALS (ACM)
LEAD-BASED PAINTS (LBP)**

**26 Oakley Street
Poughkeepsie, NY 12601
Emergency Housing Project**

QuES&T Project #22-5043

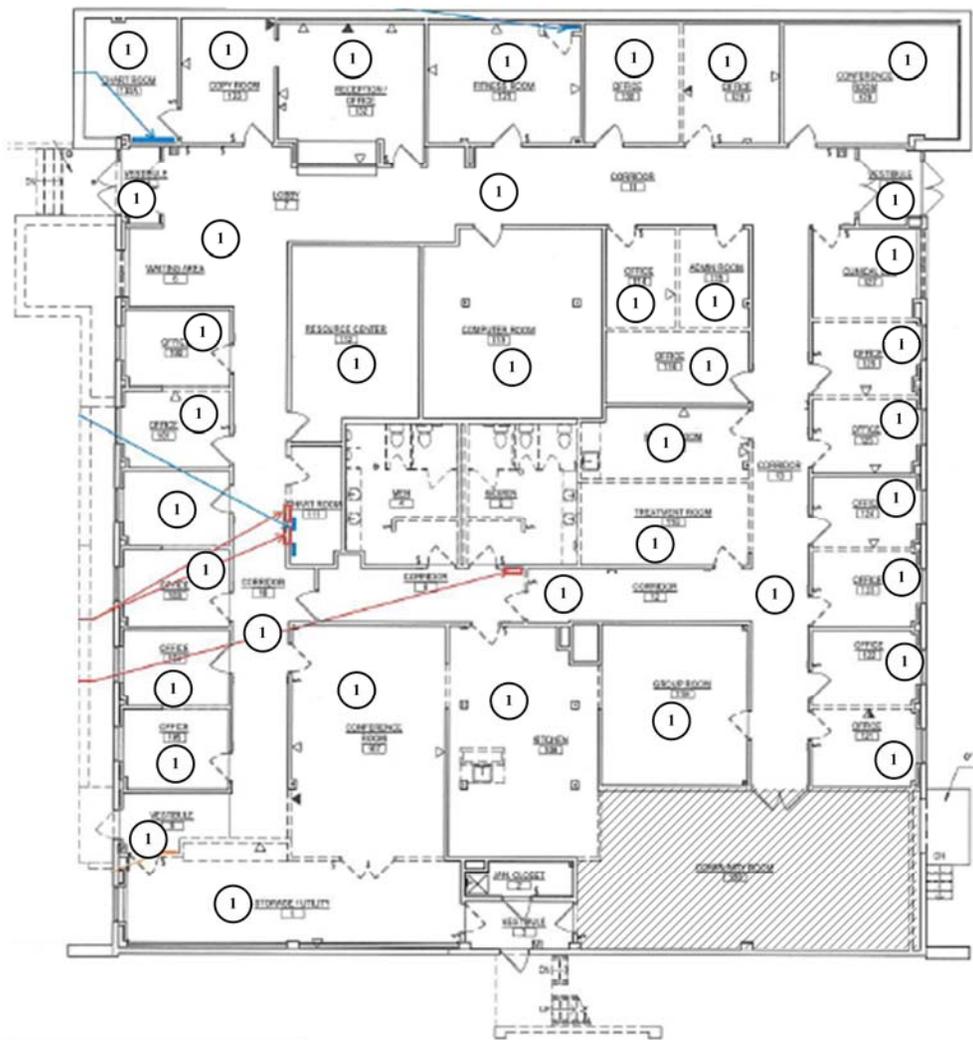
ASB-01

ACM 9"X9" GRAY FLOOR TILE & MASTIC UNDER PLANK FLOORING
①	ACM FLOOR TILE & MASTIC (SOME CONCEALED/DOUBLE LAYERED)
ACM JOINT COMPOUND THROUGHOUT ENTIRE SPACE

1ST FLOOR PLAN
ASBESTOS LOCATIONS

Prior to conducting demolition or construction work at the building, all ACM affected/impacted by such activities shall be removed utilizing a licensed asbestos abatement contractor and NYSDOL/EPA/NYC certified personnel prior to construction/demolition activities. All work conducted should be in accordance with all legal requirements, including but not limited to U.S. Environmental Protection Agency (EPA) National Emissions Standards for Hazardous Air Pollutants (NESHAP) [40 CFR Part 61], New York State Industrial Code Rule 56 Asbestos Regulations (ICR 56) and Chapter 1 of Title 15 of the Rules of the City of New York Regulations, as applicable. Advance notification of the asbestos project to the USEPA, NYSDOL, and NYCDEP may be required.

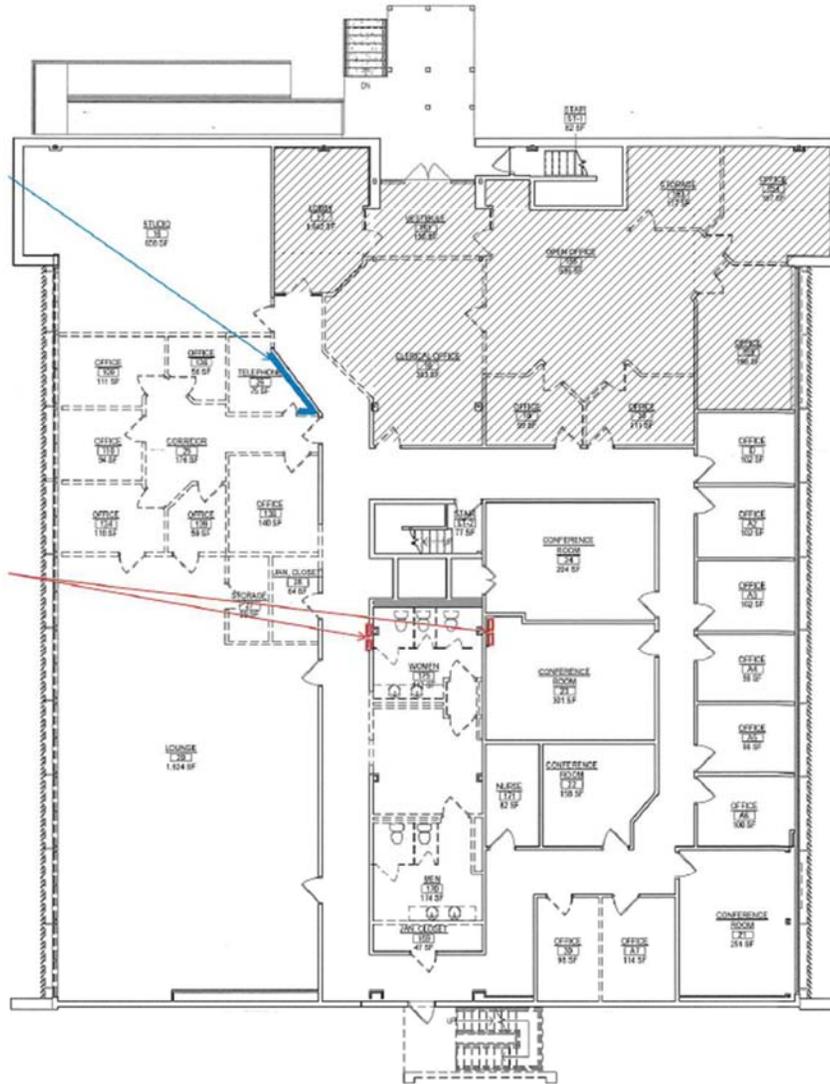
ASB-02

ACM LOCATION KEY (Refer to Report for Details)	
	ACM FLOOR TILE & MASTIC UNDER CERAMIC TILE
	ACM JOINT COMPOUND THROUGHOUT ENTIRE SPACE

2ND FLOOR PLAN
ASBESTOS LOCATIONS

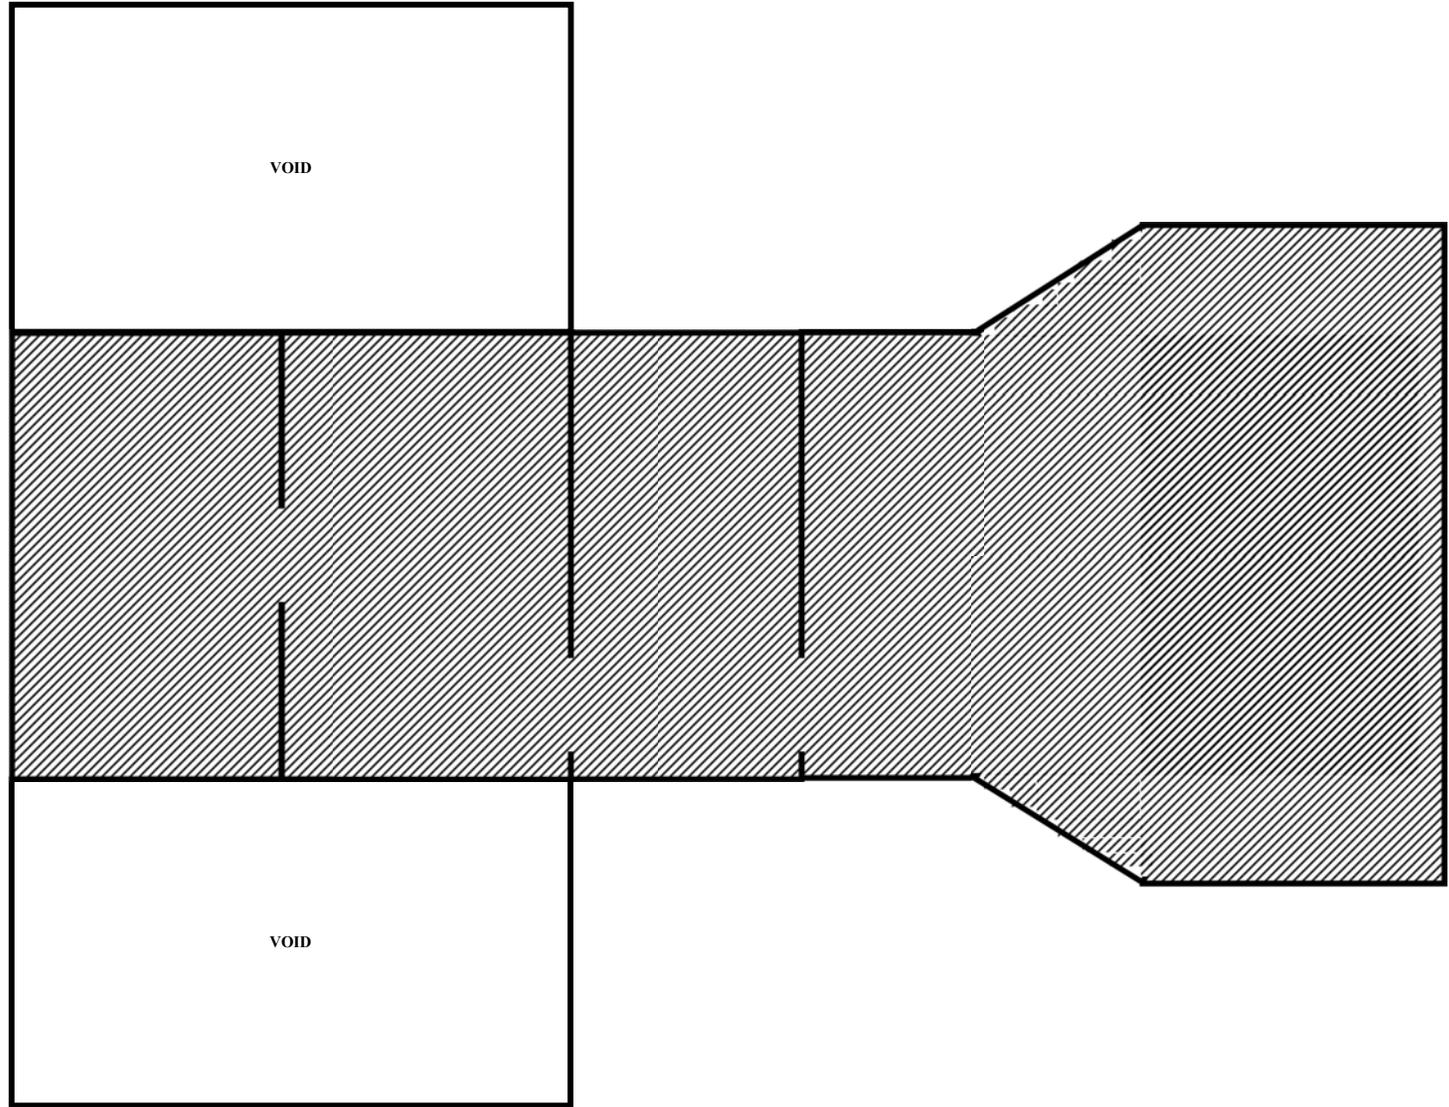
ASB-03

**3RD FLOOR PLAN
ASBESTOS LOCATIONS**

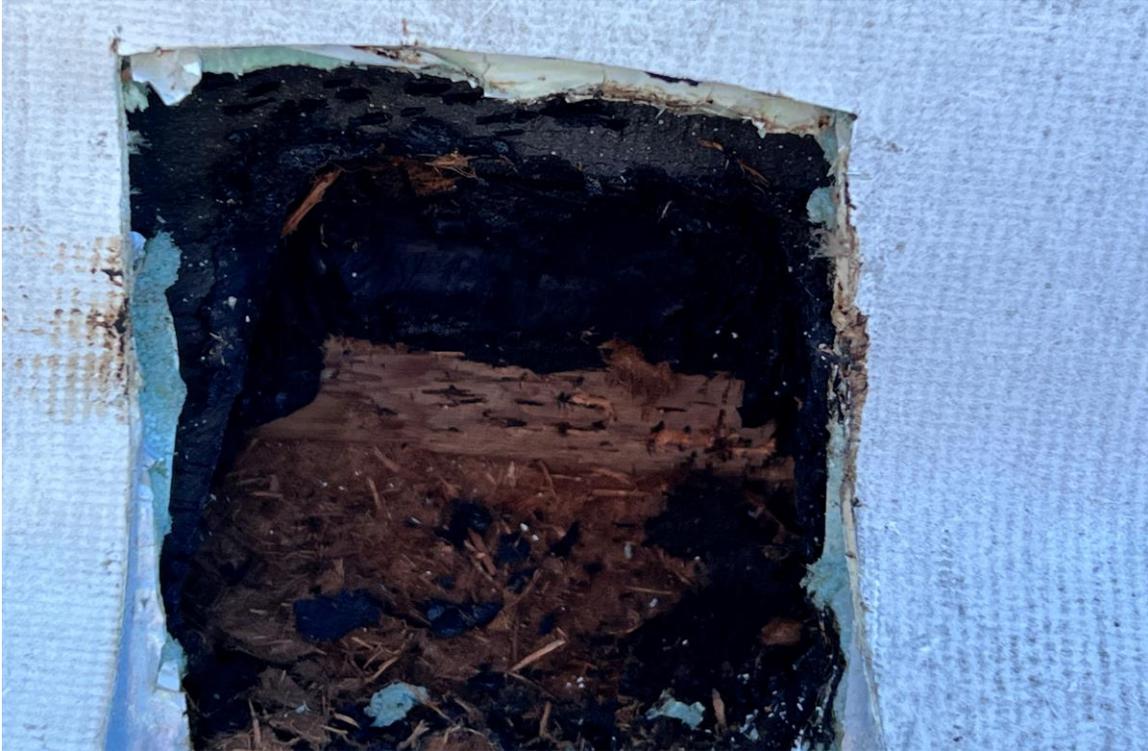
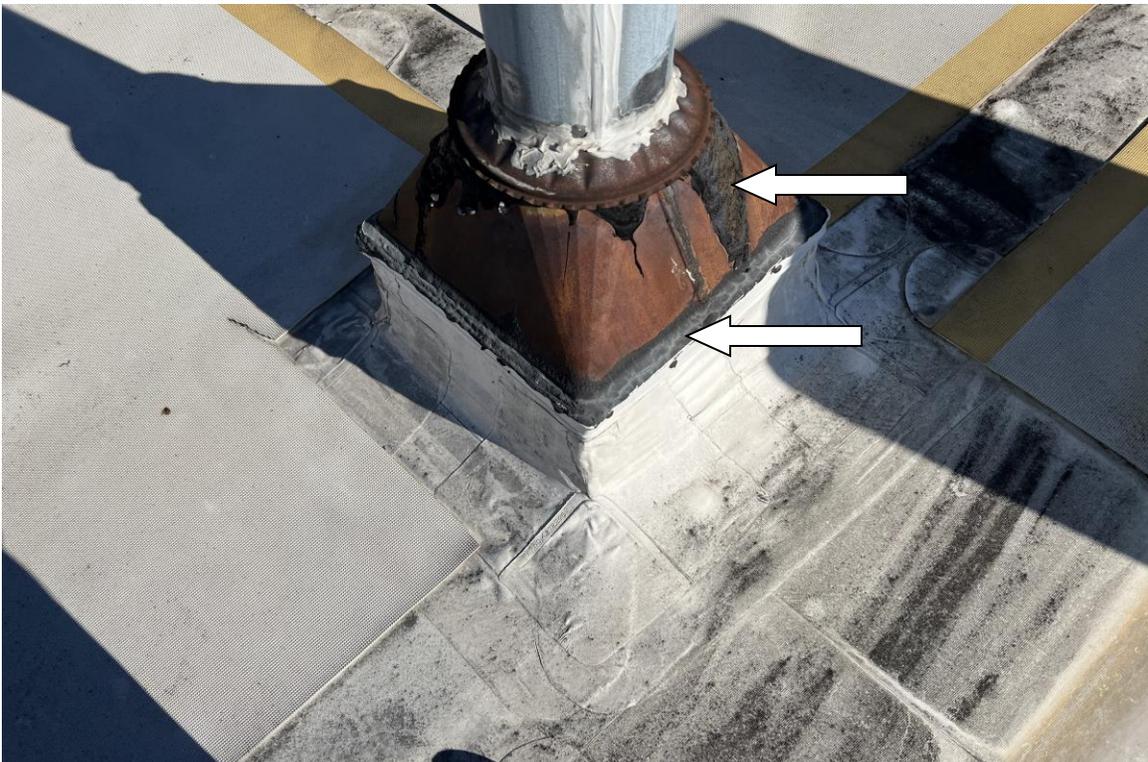
**ABOVE: ACM TAR ON PARAPIT & ACM BUILT UP ROOF (PERIMETER)
BELOW: ACM TAR & TAR FLASHING ON VENT STACK**

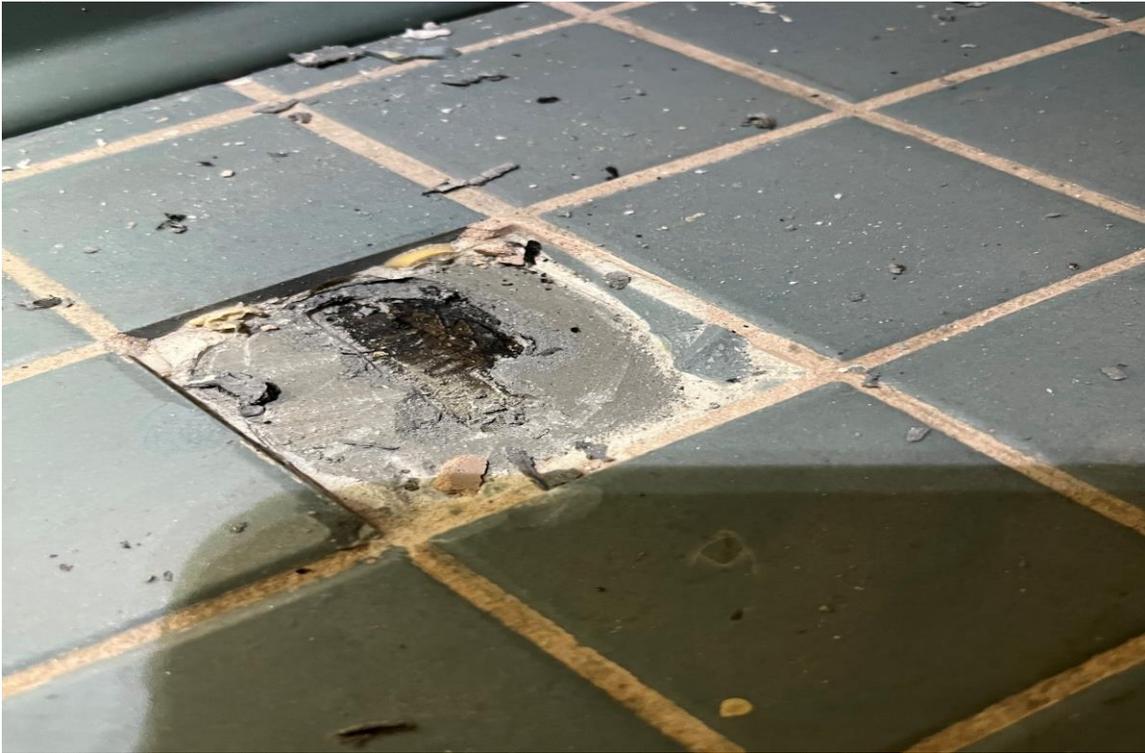
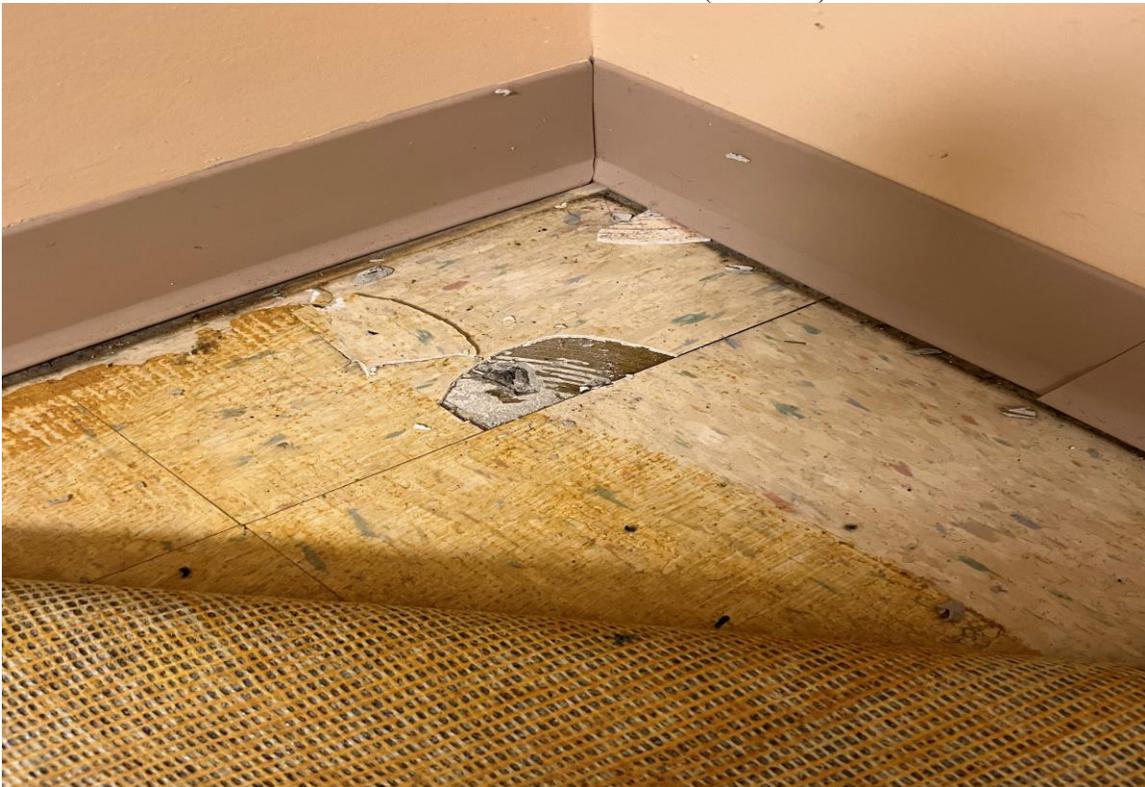
**ABOVE: SECOND FLOOR, OFFICE CLOSET – ACM SECOND LAYER FLOOR TILE & MASTIC
BELOW: FIRST FLOOR – ACM SECOND LAYER FLOOR TILE (TYPICAL)**

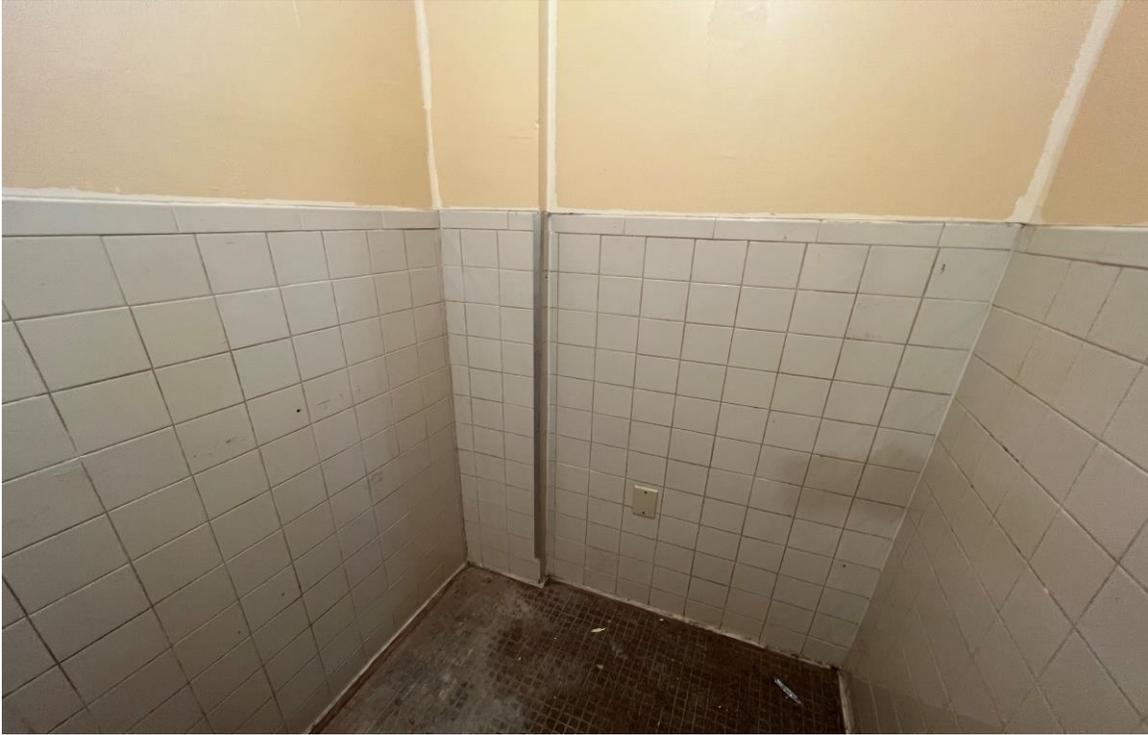
ABOVE: ACM JOINT COMPOUND & CONTAMINATED SHEETROCK (TYPICAL)

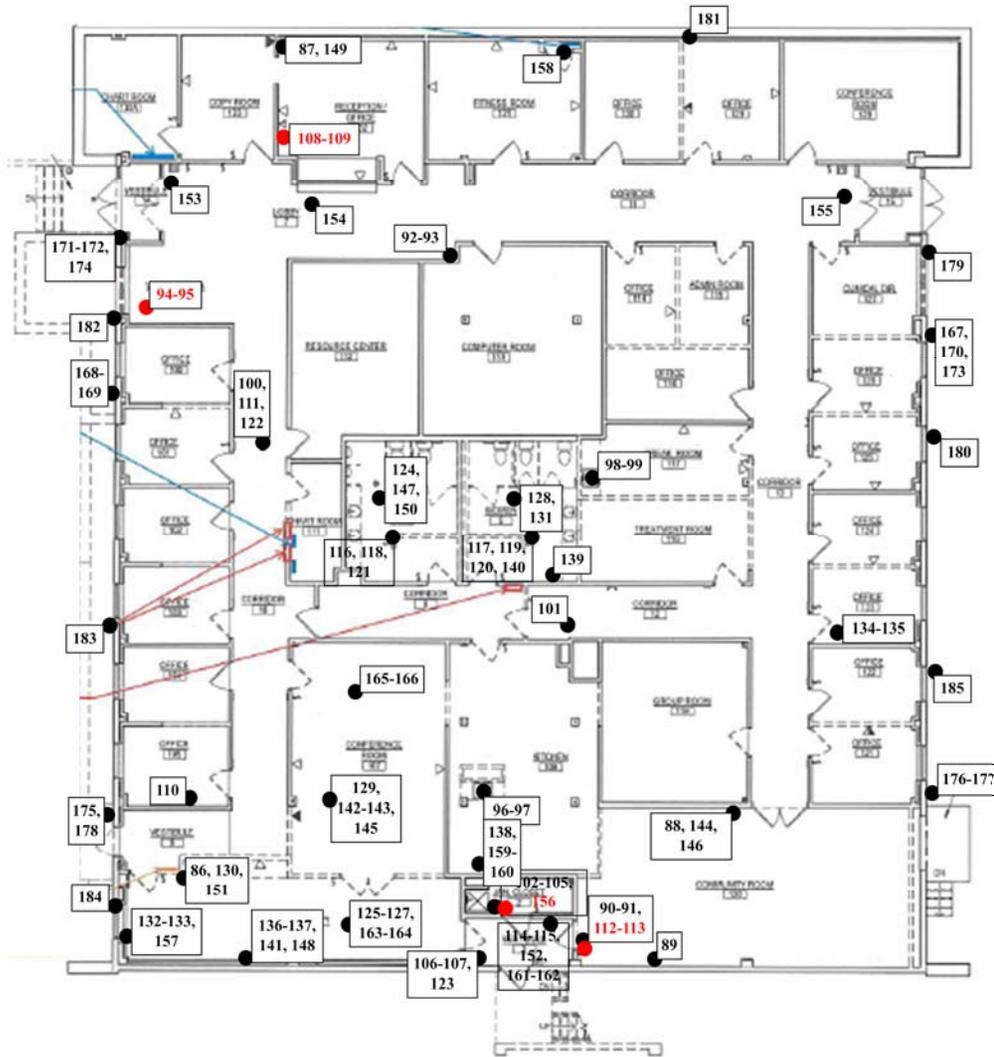
ACM LOCATION KEY (Refer to Report for Details)	
●	Non-ACM Sample Location
●	ACM Sample Location

Quality Environmental Solutions & Technologies, Inc. 1376 Route 9 Wappingers Falls, NY 12590 Phone: (845) 298- 6031 Fax: (845) 298-6251	
CLIENT	
DUTCHESS COUNTY DPW 22 MARKET STREET POUGHKEEPSIE, NY 12601	
PROJECT LOCATION	
26 OAKLEY STREET POUGHKEEPSIE, NY 12601	
1ST FLOOR & EXTERIOR PLAN SAMPLE LOCATIONS	
SL-01

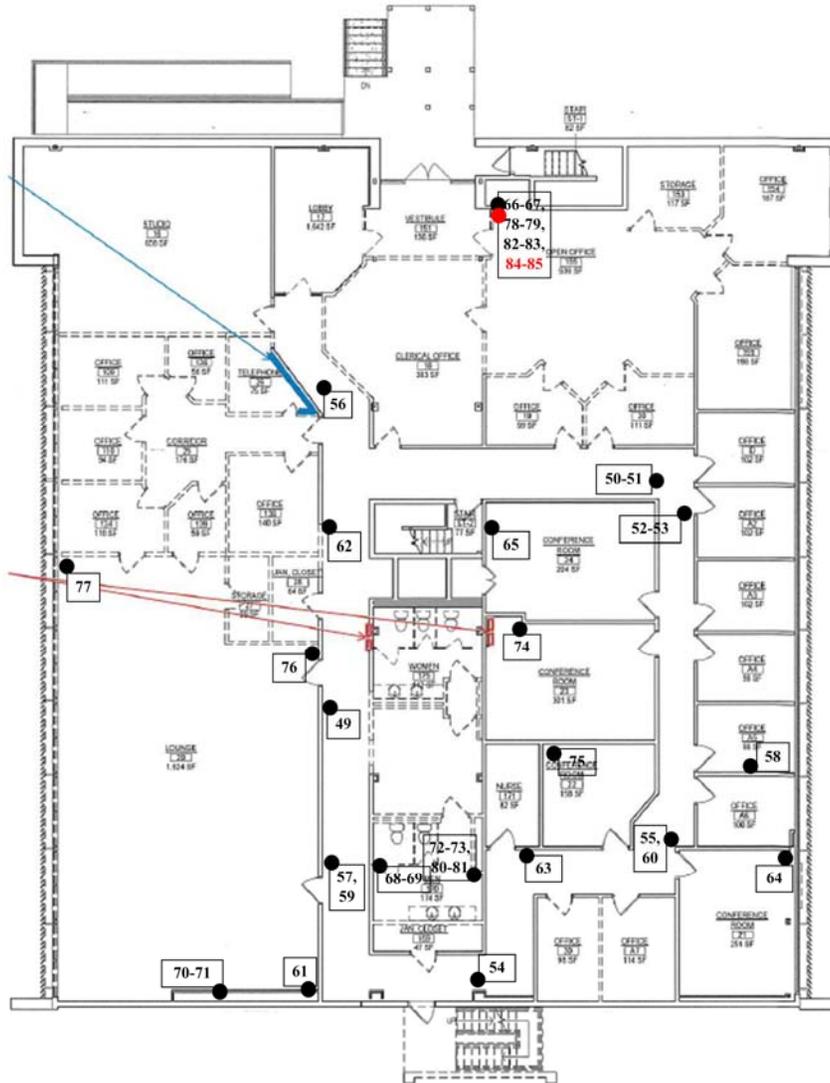
SL-02

ACM LOCATION KEY (Refer to Report for Details)	
●	Non-ACM Sample Location
●	ACM Sample Location

2ND FLOOR PLAN
SAMPLE LOCATIONS

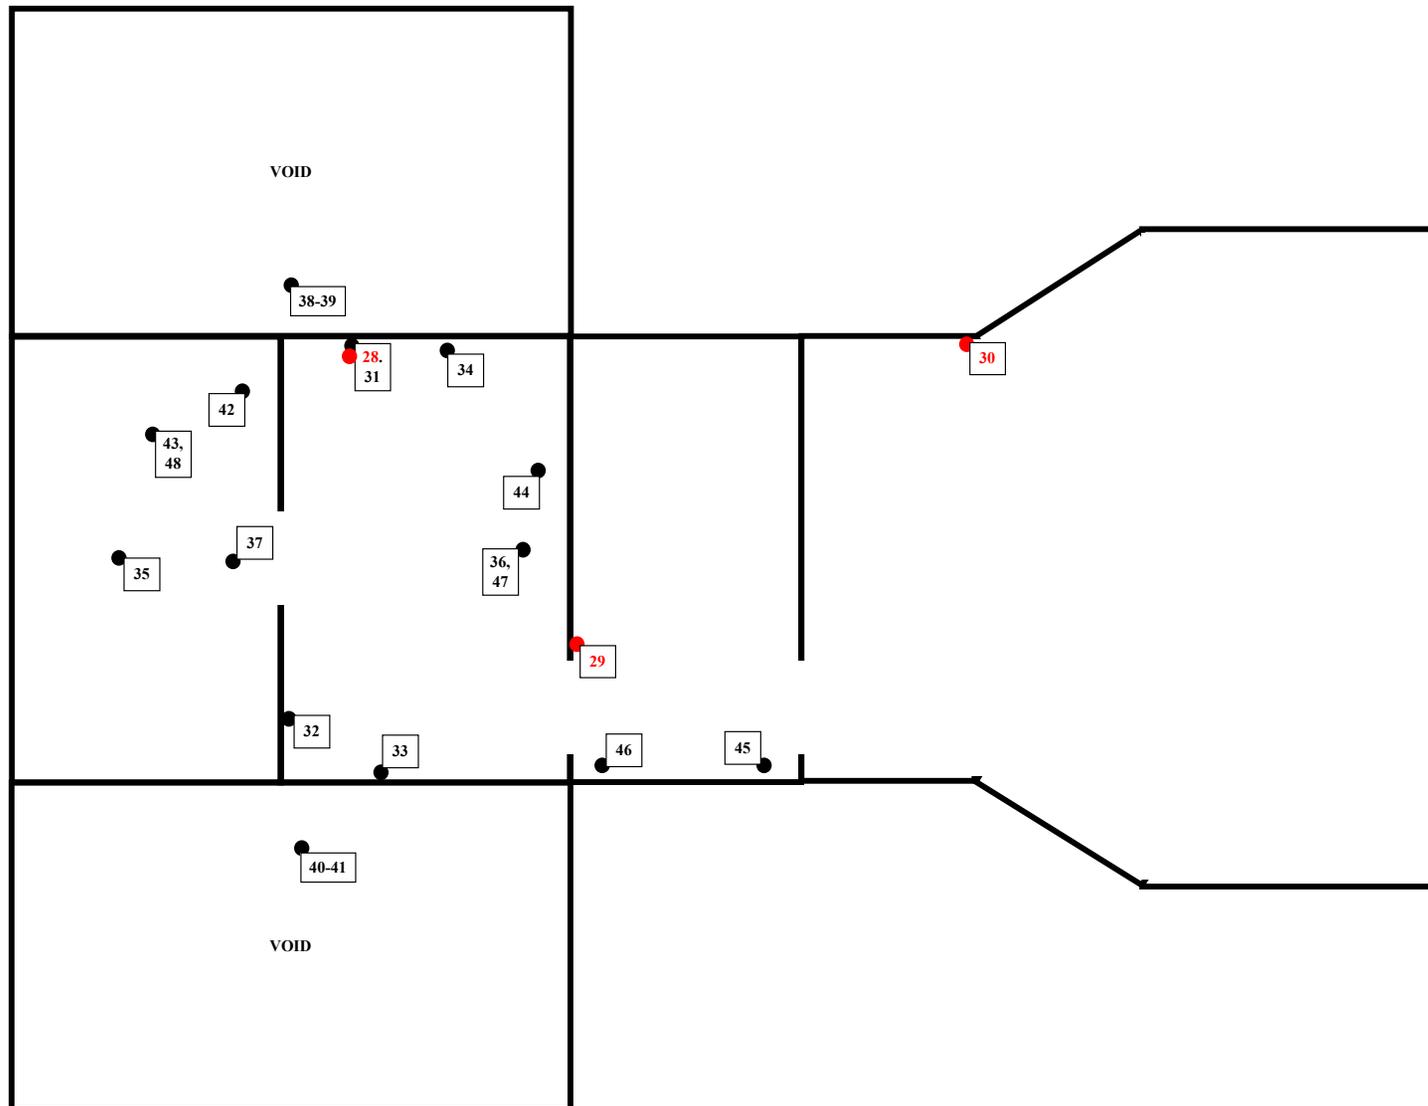
ACM LOCATION KEY (Refer to Report for Details)	
●	Non-ACM Sample Location
●	ACM Sample Location

<p>Quality Environmental Solutions & Technologies, Inc. 1376 Route 9 Wappingers Falls, NY 12590 Phone: (845) 298- 6031 Fax: (845) 298-6251</p>	
CLIENT	
<p>DUTCHESS COUNTY DPW 22 MARKET STREET POUGHKEEPSIE, NY 12601</p>	
PROJECT LOCATION	
<p>26 OAKLEY STREET POUGHKEEPSIE, NY 12601</p>	
3RD FLOOR PLAN SAMPLE LOCATIONS	
SL-03

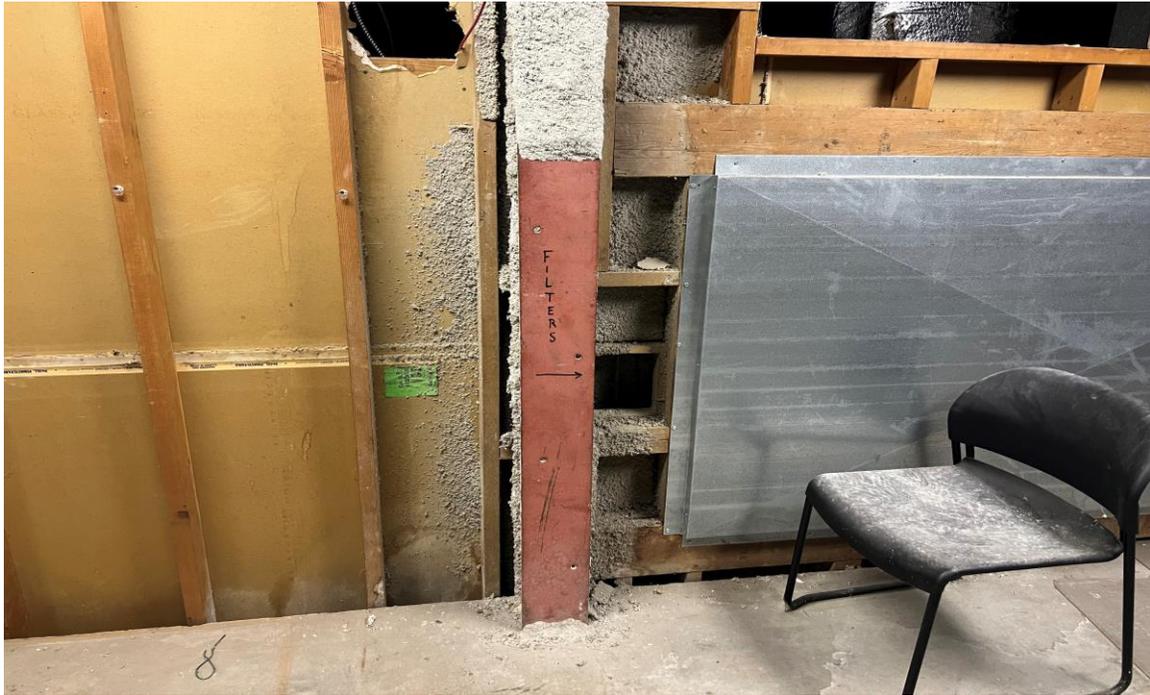
Location	LBP Component	Substrate	Color	LBP Condition	Quantity
INTERIOR					
Third Floor, Mechanical Room	Structural Beams	Metal	Red/Brown	Good	Indeterminate ¹

ABOVE: LBP Structural Beam

It should be noted that several components tested did in fact contain minimal lead-levels below the EPA threshold level of 1.0 mg/sq. cm for classification as Lead-Based Paint (LBP) and are considered lead-containing coatings by the OSHA Regulation, “Lead Exposure in Construction” (29 CFR 1926.62). OSHA does not recognize a minimum limit for lead concentrations in paint for the purposes of disturbance. Monitoring of workers performing demolition/cleaning/disturbance of painted surfaces shall be completed to document personnel occupational exposure. Items containing any amount of lead concentration are considered lead-containing coatings per 29 CFR 1926.62, OSHA Lead Exposure in Construction.
