**ADDENDUM NO. 2**

Re: Millbrook Central School District  
Bond Projects, Phase 1A  
At Millbrook Middle School  
SED No: 13-22-01-04-0-008-016

BBS File No. 25-237

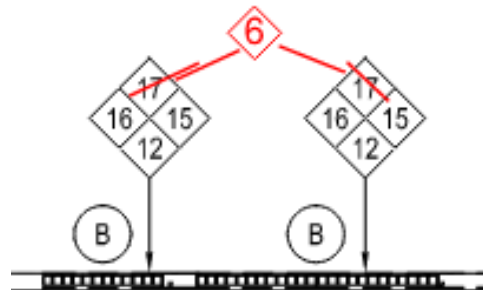
10. Demolition note 17 occurs on A1.01 at some of the gym openings but the note is not listed in the demo key notes legend. Please clarify,

**Answer: Replace note #17 with note #6, which is only found in the gymnasium (room #39).**

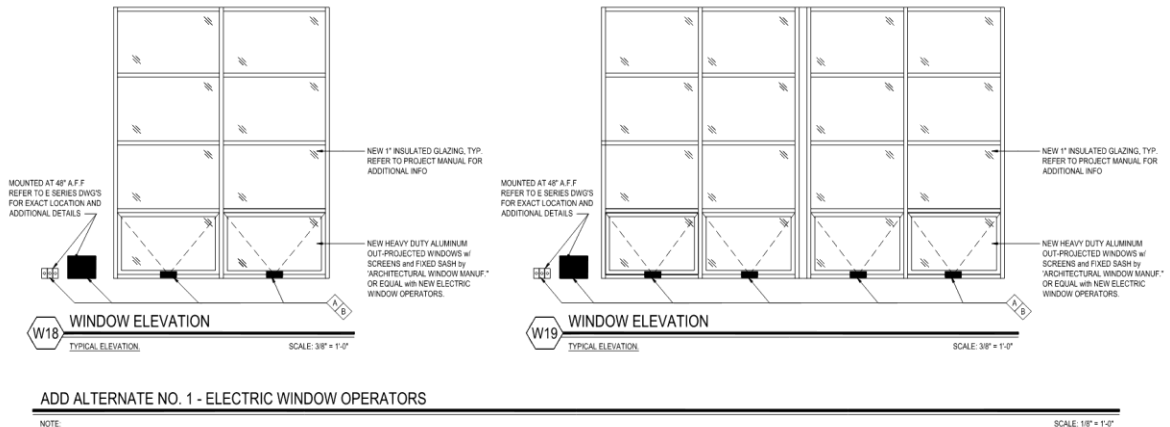
12. Drawing A8.03- Base bid windows W18 and W19 only show operating vents at the bottom. Alternate No1 shows additional operating vents at the top without the low voltage operating system. Are these vents at the top required and should they also have the low voltage operating system.

**Answer: No, only the bottom windows will be operating; top windows are fixed.**

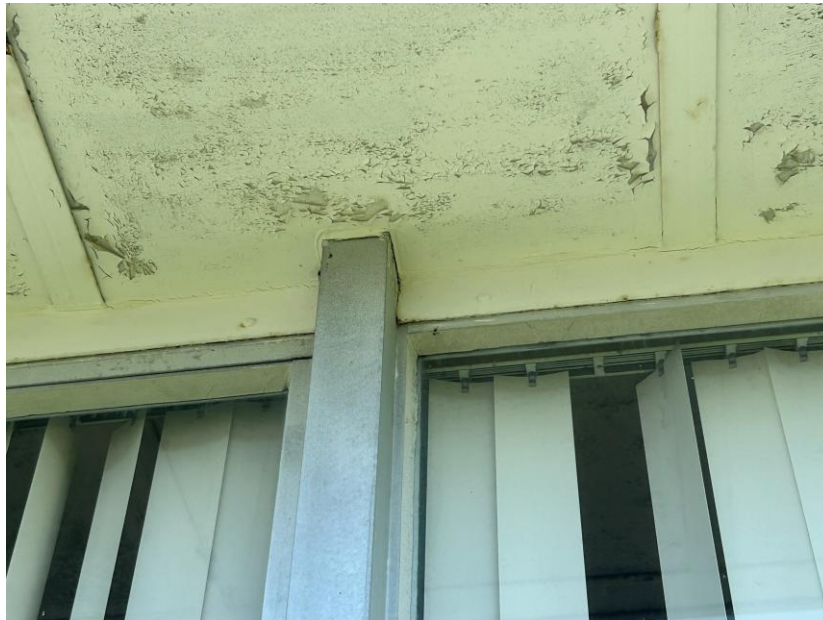
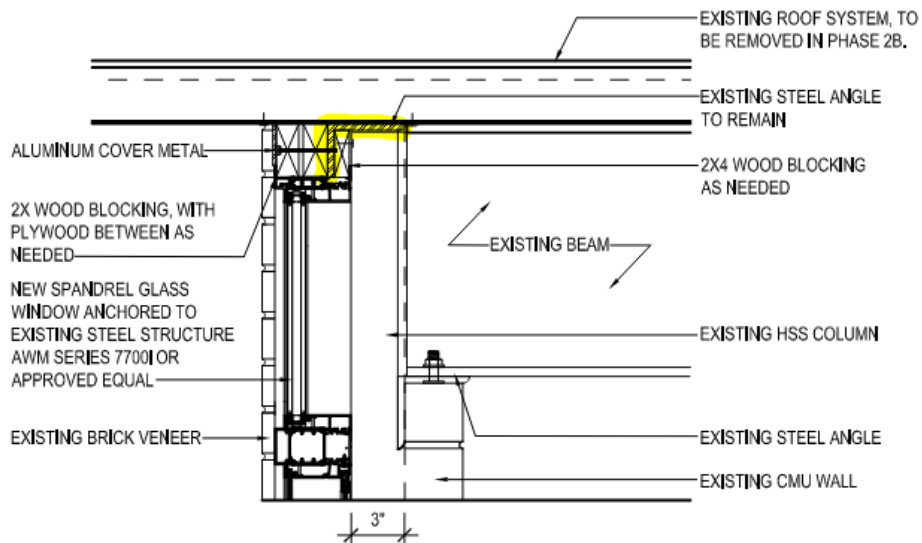
**H1** WINDOW HEAD DETAIL

15. During the site walkthrough it was observed that many of the exterior windows have exterior angles or soffits with a downturned leg at the window heads. Angels/soffits with downturned legs appear to be one piece. Must the downturned leg be removed, or can the window contractor provide blocking to the bottom of the downturned leg so that the head of new windows are flush with the bottom of the downturned leg? If the downturned leg must be removed, please clarify if it is one piece with the existing soffit and if it will need to be cut off of the existing soffit which remains in place. See pictures on next page.

**Answer:** Refer to detail # H1 A8.04; the steel angle will be retained, the new window will be installed below the angle, and the contractor will supply and install treated wood blocking as needed to compensate for the difference in thickness to the depth of the new window frame, bringing it flush with it and covering it with aluminum cover plate same finish color as the frame.

18. Please clarify attachment of "aluminum cover metal" in detail H1/A8.04. Detail shows fastener off back of metal cover plate but how the fastener attaches to the cover plate is not clear. Please clarify.

**Answer:** The fastener shown in the detail is used to anchor the wood blocking to the existing steel angle after the aluminum cover plate is fastened to it.

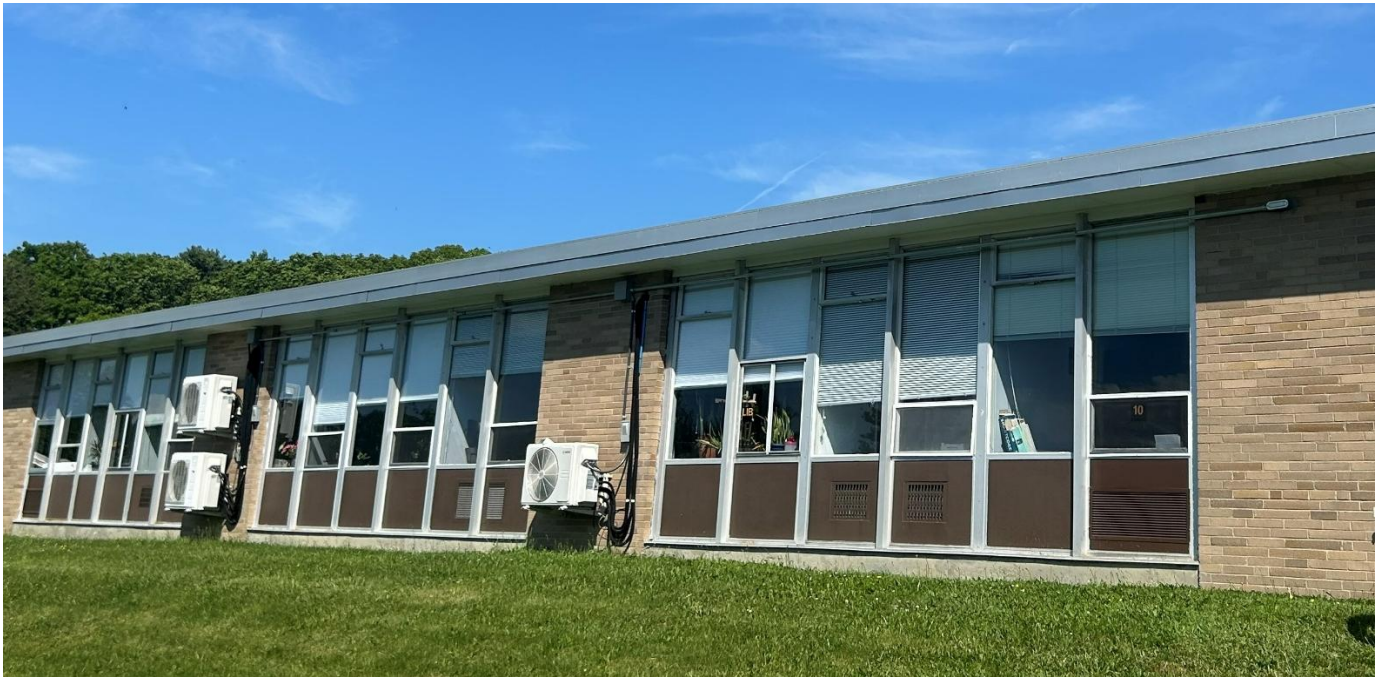
17. During the site walkthrough it was observed that there was exterior conduit mounted to existing windows. This work is not identified on the architectural drawings. Please see picture on next page and clarify what this is, and which contract is responsible for work related to it.

**Answer:** This will be added to the electrical contractor's scope of work to temporarily remove and reinstall these two conduits after the new windows are installed.
