# **Hazmat Survey Report for the Kensico Laboratory, Rev. 1**

**In support of  
Contract CAT-423**

**May, 2018**

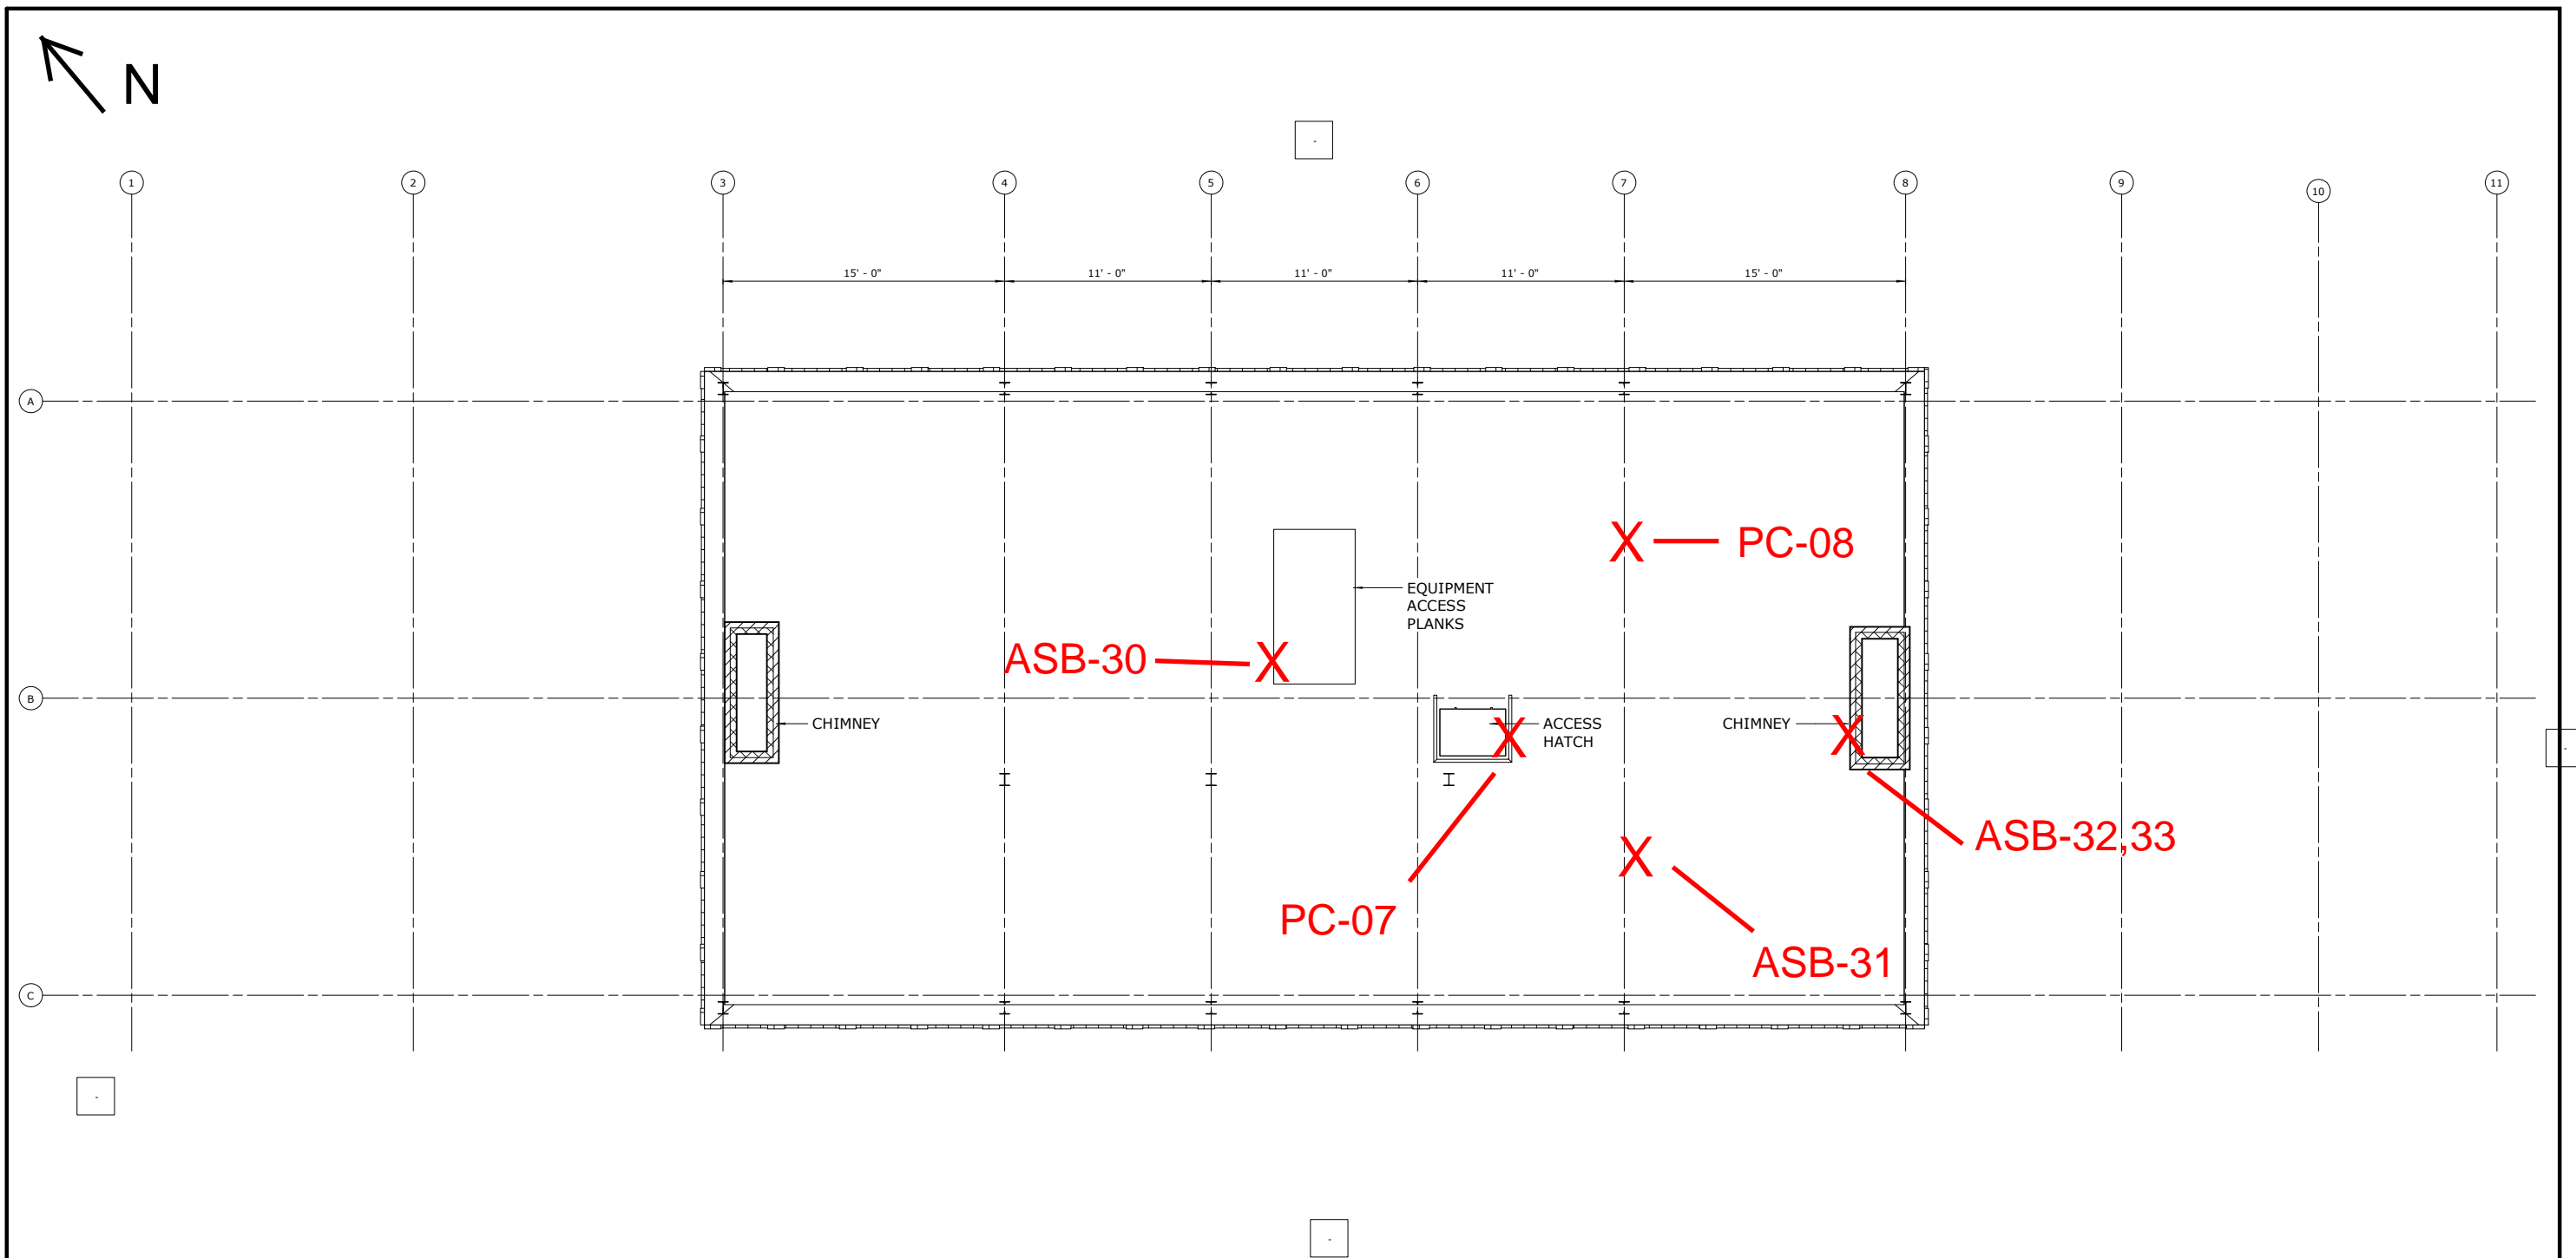
**FIGURE 2. KENSICO LABORATORY, ATTIC  
 HAZARDOUS MATERIALS SAMPLE LOCATIONS  
 CONTRACT CAT-423**

Notes:  
 Sample IDs have been abbreviated.  
 Full IDs can be found in Tables 1 and 4.

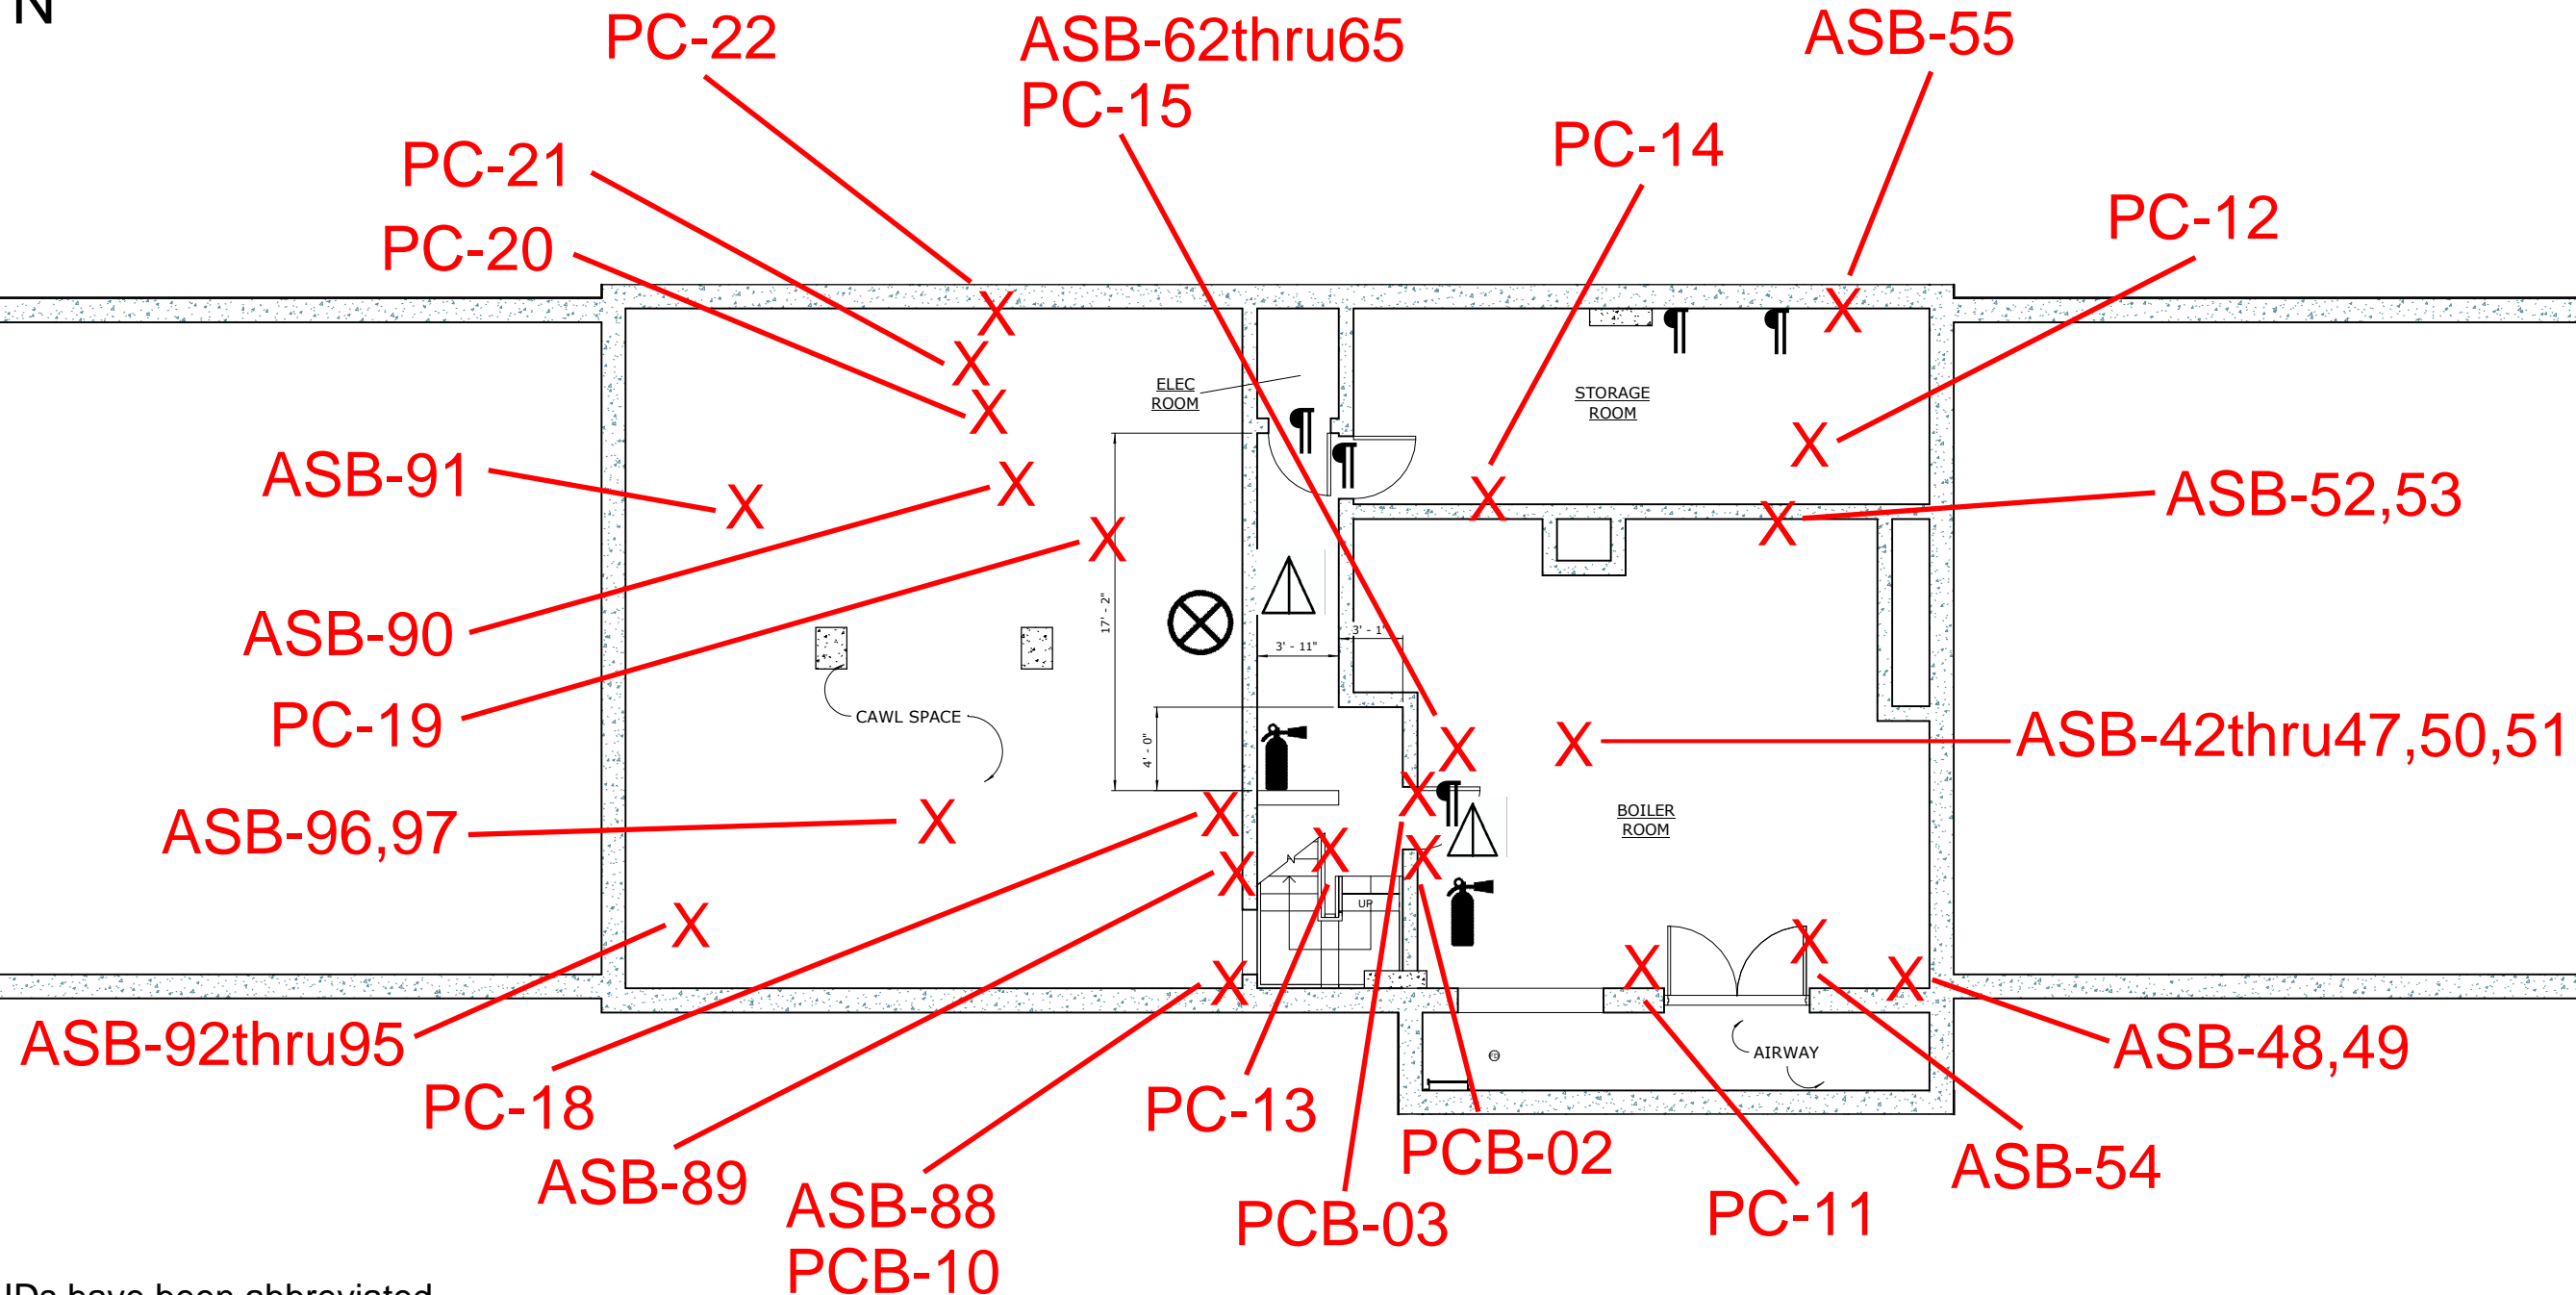
**FIGURE 5. KENSICO LABORATORY, BASEMENT HAZARDOUS MATERIALS SAMPLE LOCATIONS CONTRACT CAT-423**

Notes:  
Sample IDs have been abbreviated.  
Full IDs can be found in Tables 1, 3, and 4.
